AmericanLifelinesAlliance

Seismic Fragility Formulations For Water Systems

Part 2 – Appendices

April 2001

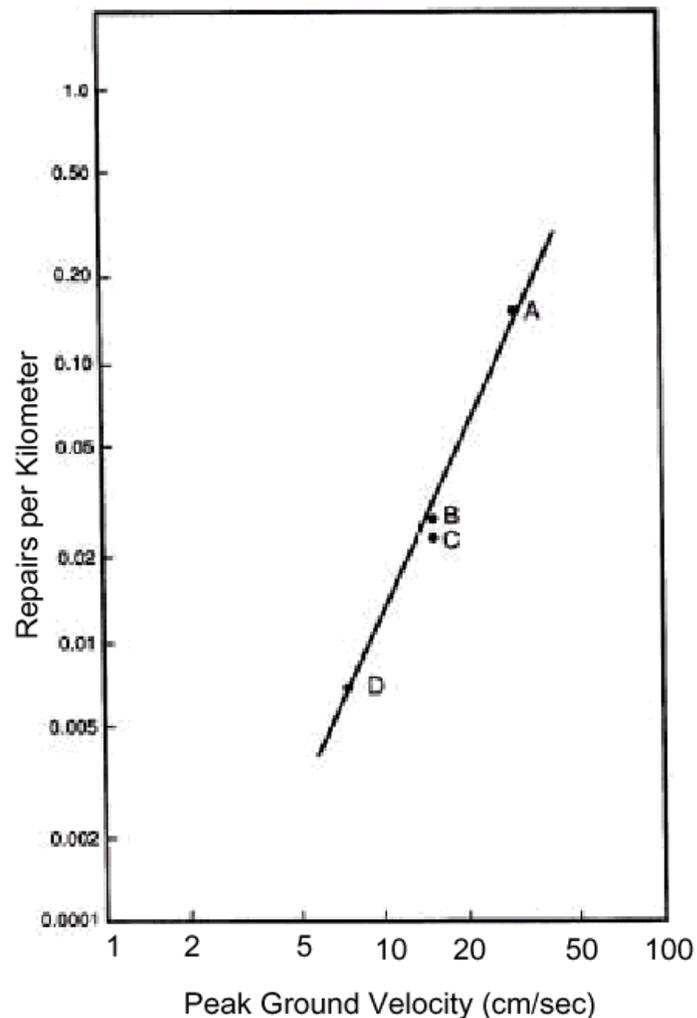
A. 1971 San Fernando. Most common - 3 to 6 inch diameter pipes. PGV = 30 cm/sec.
Observed repair rate = 0.155 repairs / km

B. 1969 Santa Rosa. Most common - 3 to 6 inch diameter pipes. PGV = 15 cm/sec.
Observed repair rate = 0.028 repairs / km

C. 1971 San Fernando. Most common - 3 to 6 inch diameter pipes. PGV = 15 cm/sec.
Observed repair rate = 0.024 repairs / km

D. 1965 Puget Sound. Most common - 8 to 10 inch diameter pipes. PGV = 7.5 cm/sec.
Observed repair rate = 0.007 repairs / km

Figure A-1. Wave Propagation Damage to Cast Iron Pipe [from Barenberg, 1988]

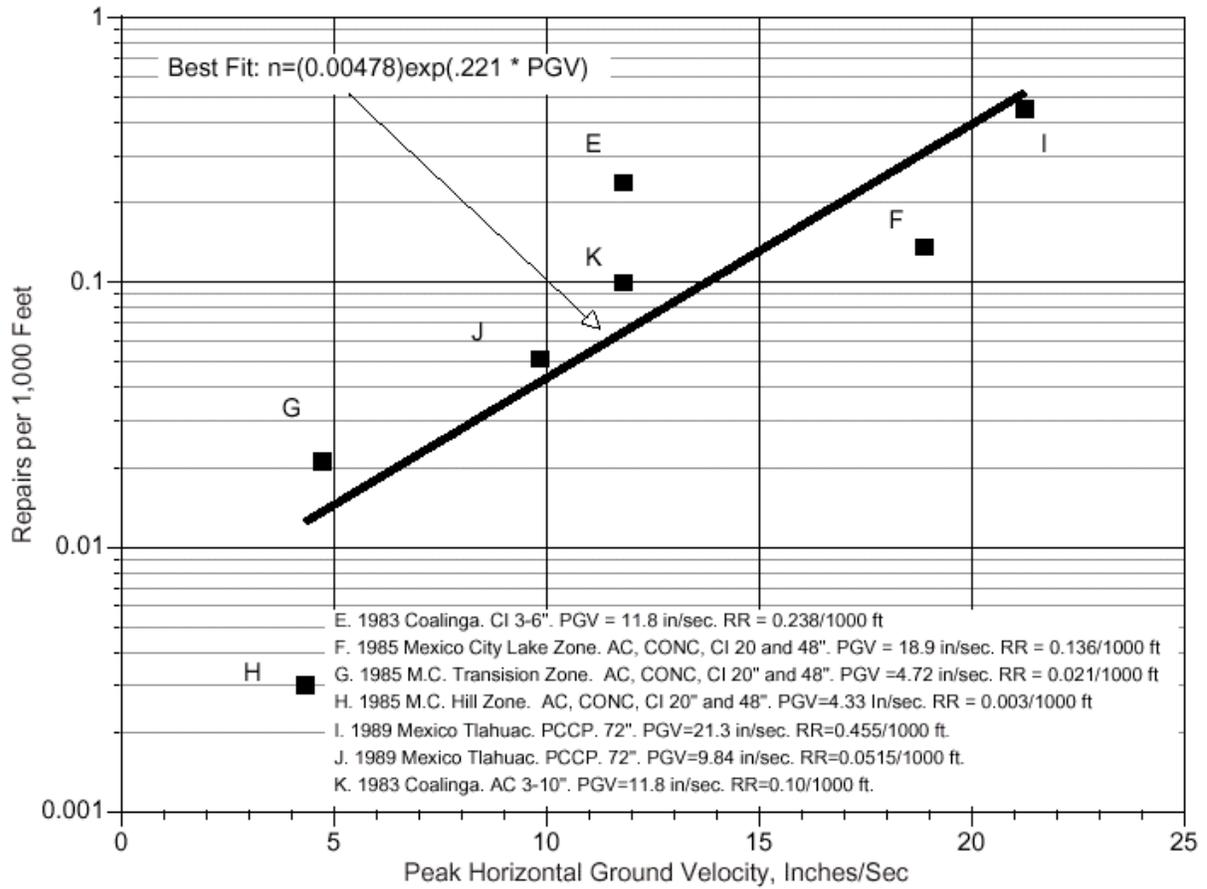
Figure A-2. Pipe Damage – Wave Propagation [from O'Rourke and Ayala, 1994]

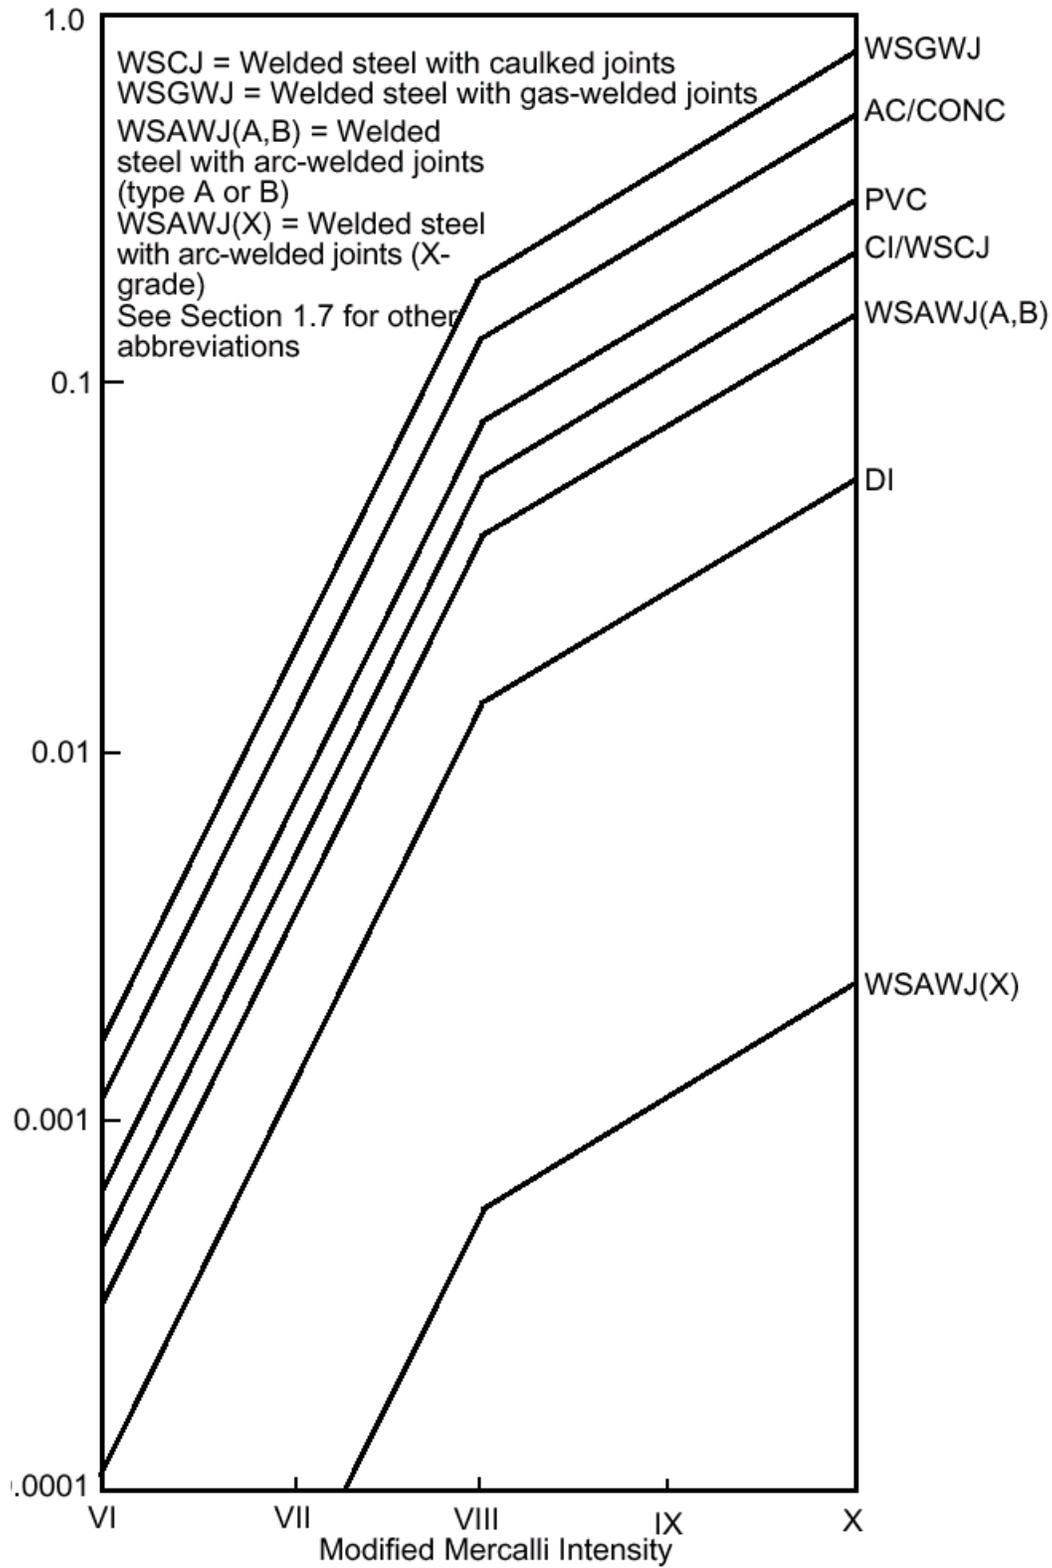
Figure A-3. Pipe Fragility Curves for Ground Shaking Hazard Only
 [from Ballentyne et al, 1990]

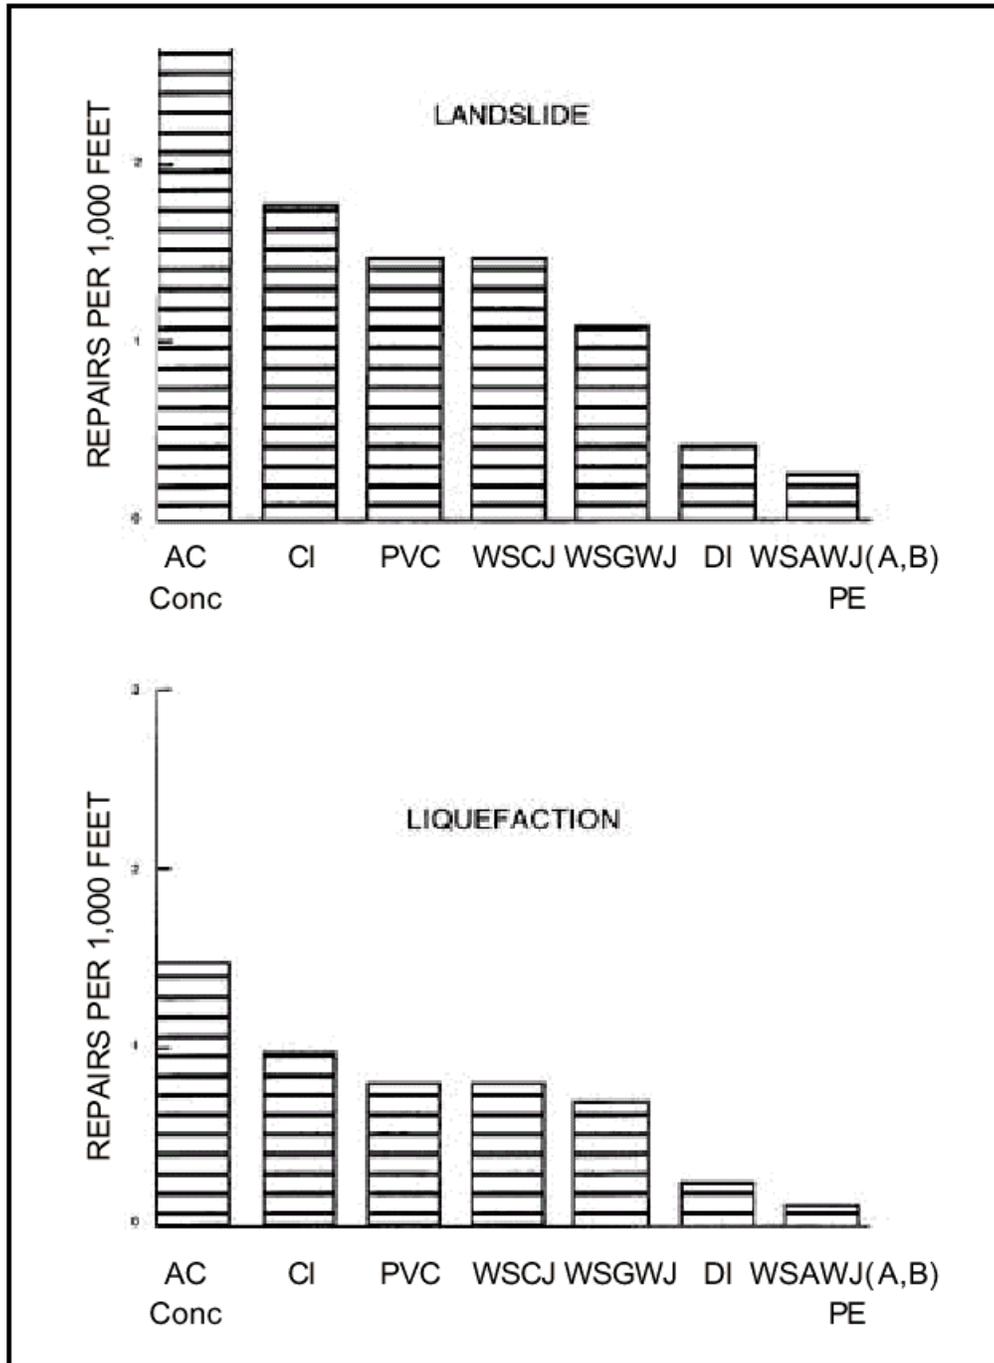
Figure A-4. Earthquake Vulnerability Models for Buried Pipelines for Landslides and Liquefaction

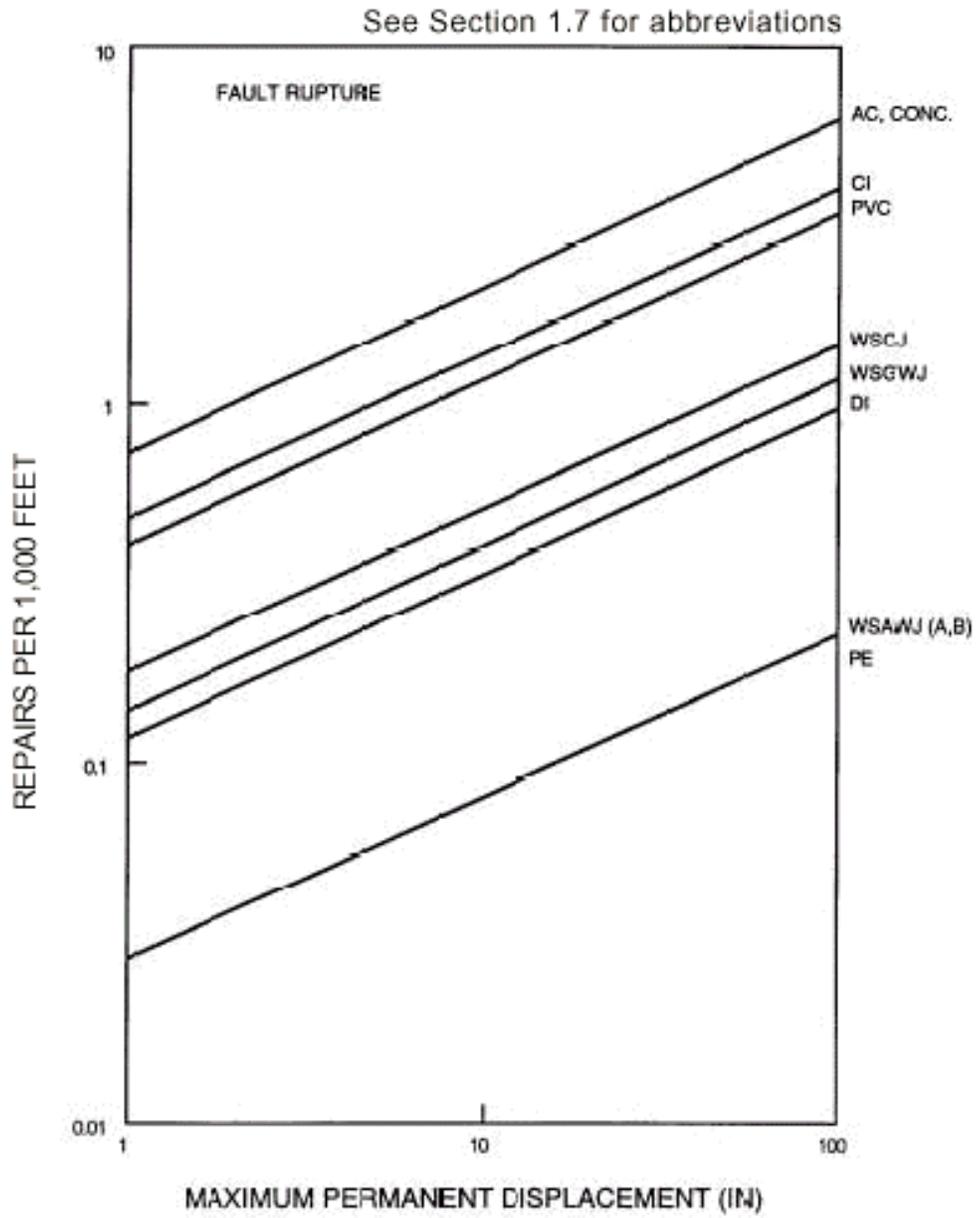
Figure A-5. Earthquake Vulnerability Models for Buried Pipelines for Fault Offset

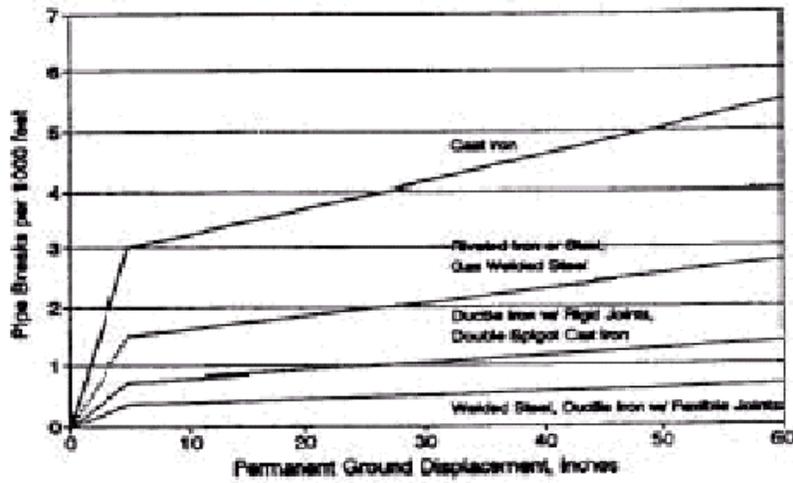
Figure A-6. PGD Damage Algorithm [from Harding and Lawson, 1991]

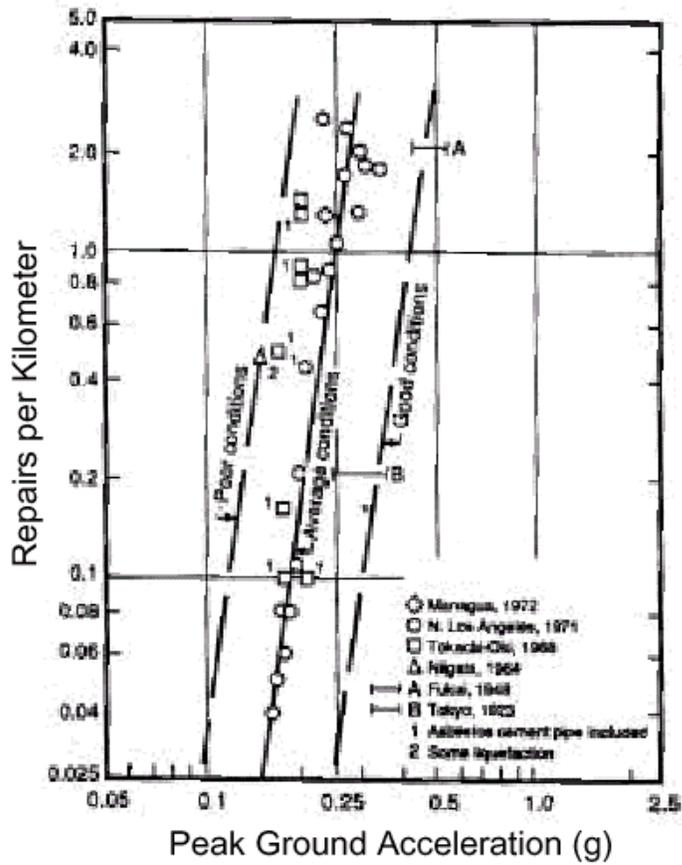
Figure A-7. Pipe Damage [from Katayama et al, 1975]

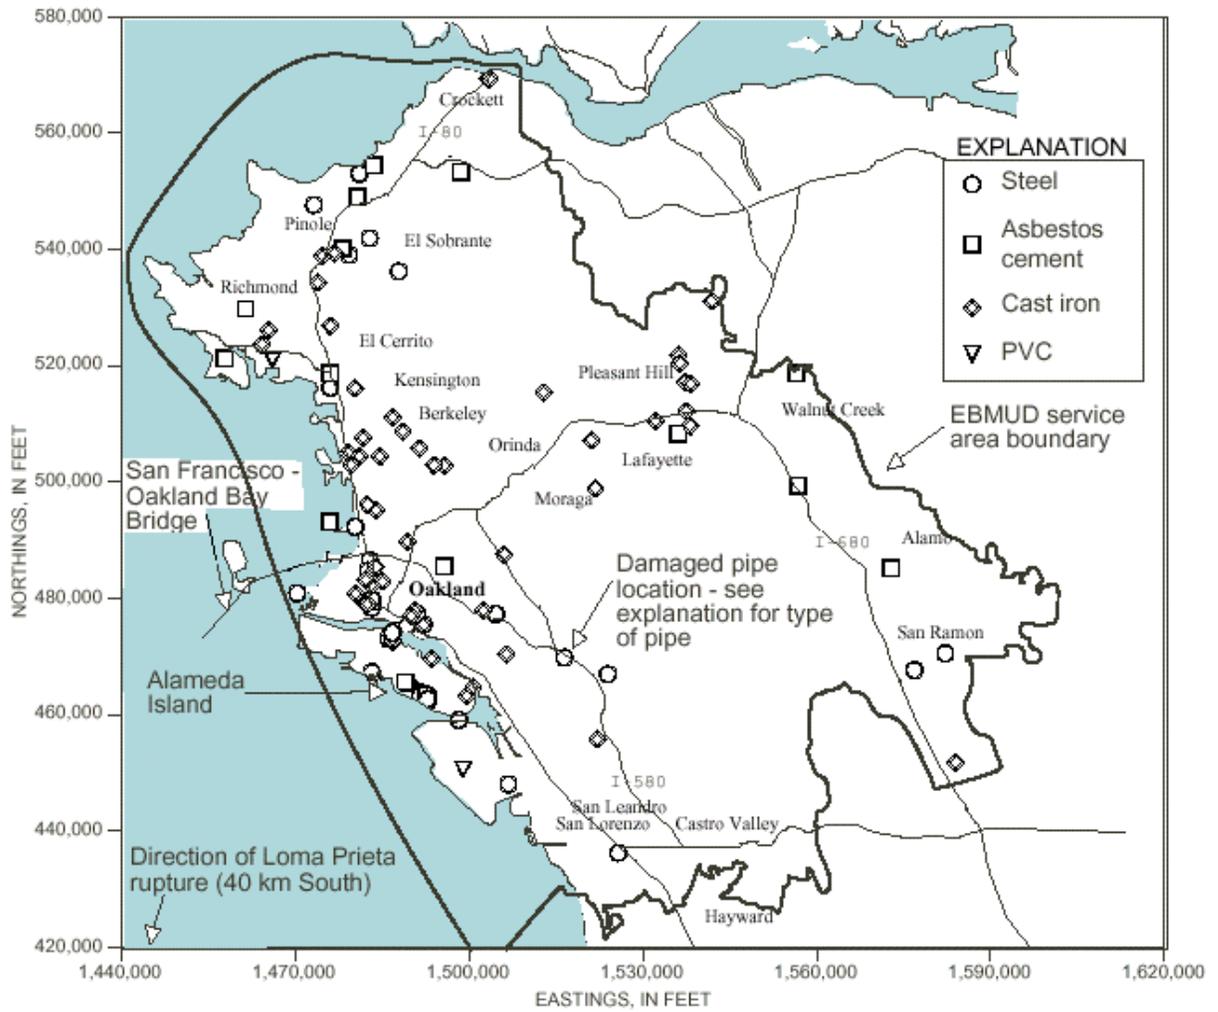
Figure A-8. Location of Pipe Repairs in EBMUD System, 1989 Loma Prieta Earthquake

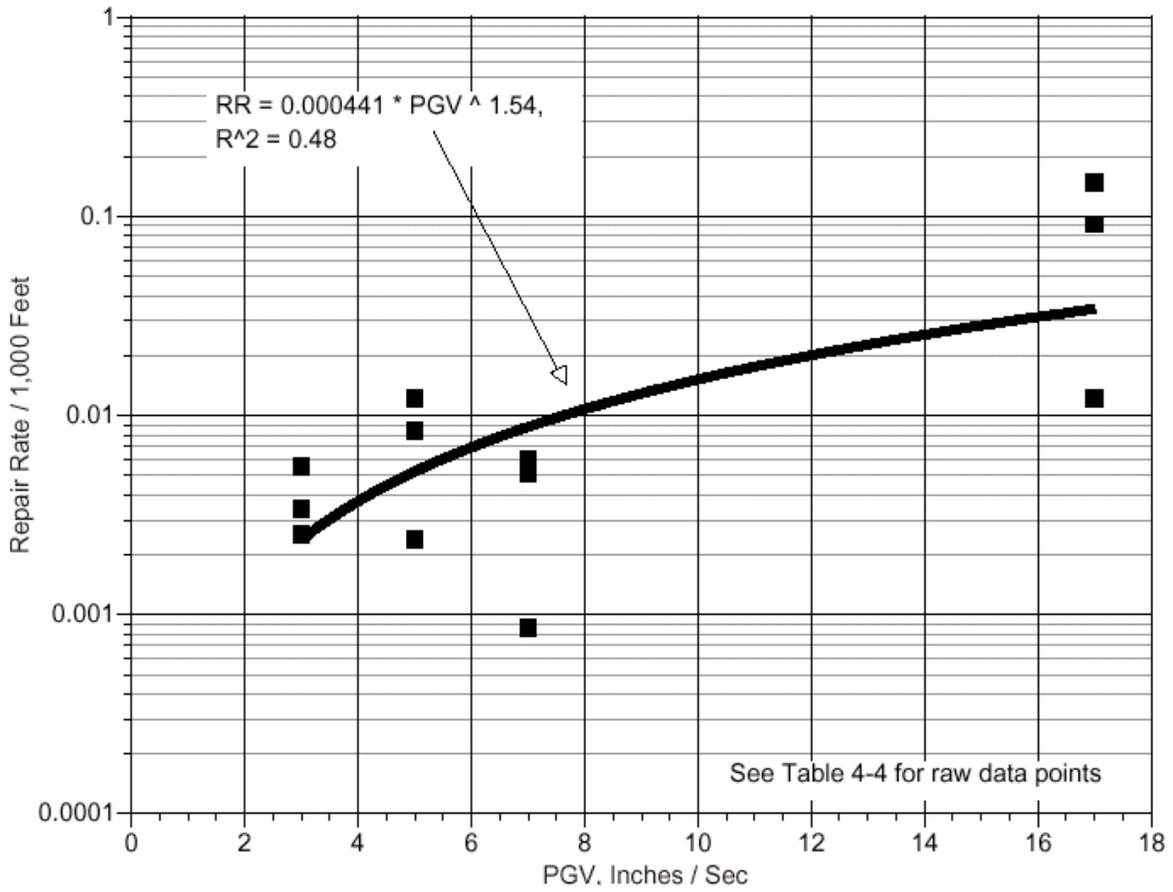
Figure A-9. Repair Rate, Loma Prieta (EBMUD), Ground Shaking, All Materials, CI, AC, WS

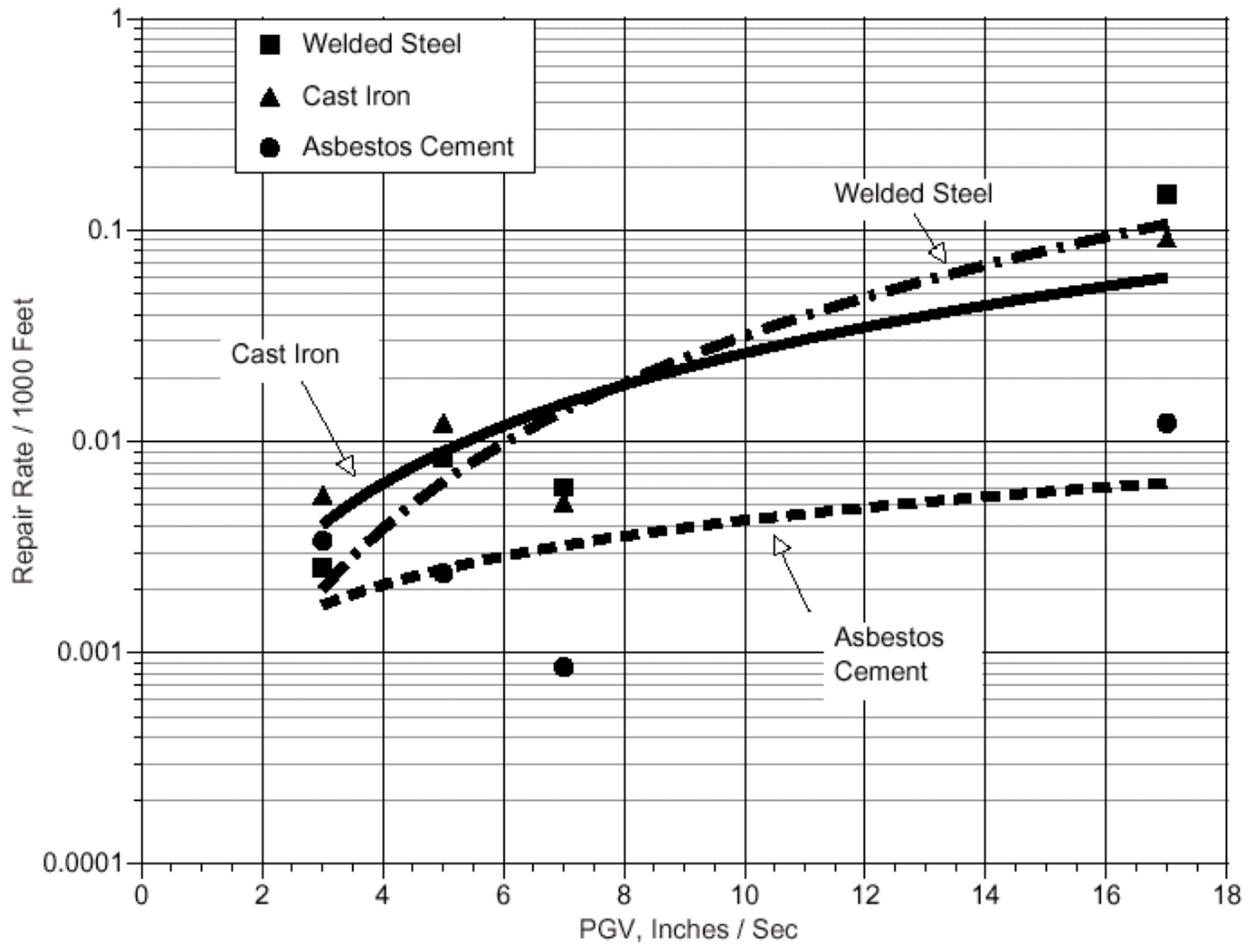
Figure A-10. Repair Rate, Loma Prieta (EBMUD), Ground Shaking, By Material, CI, AC, WS

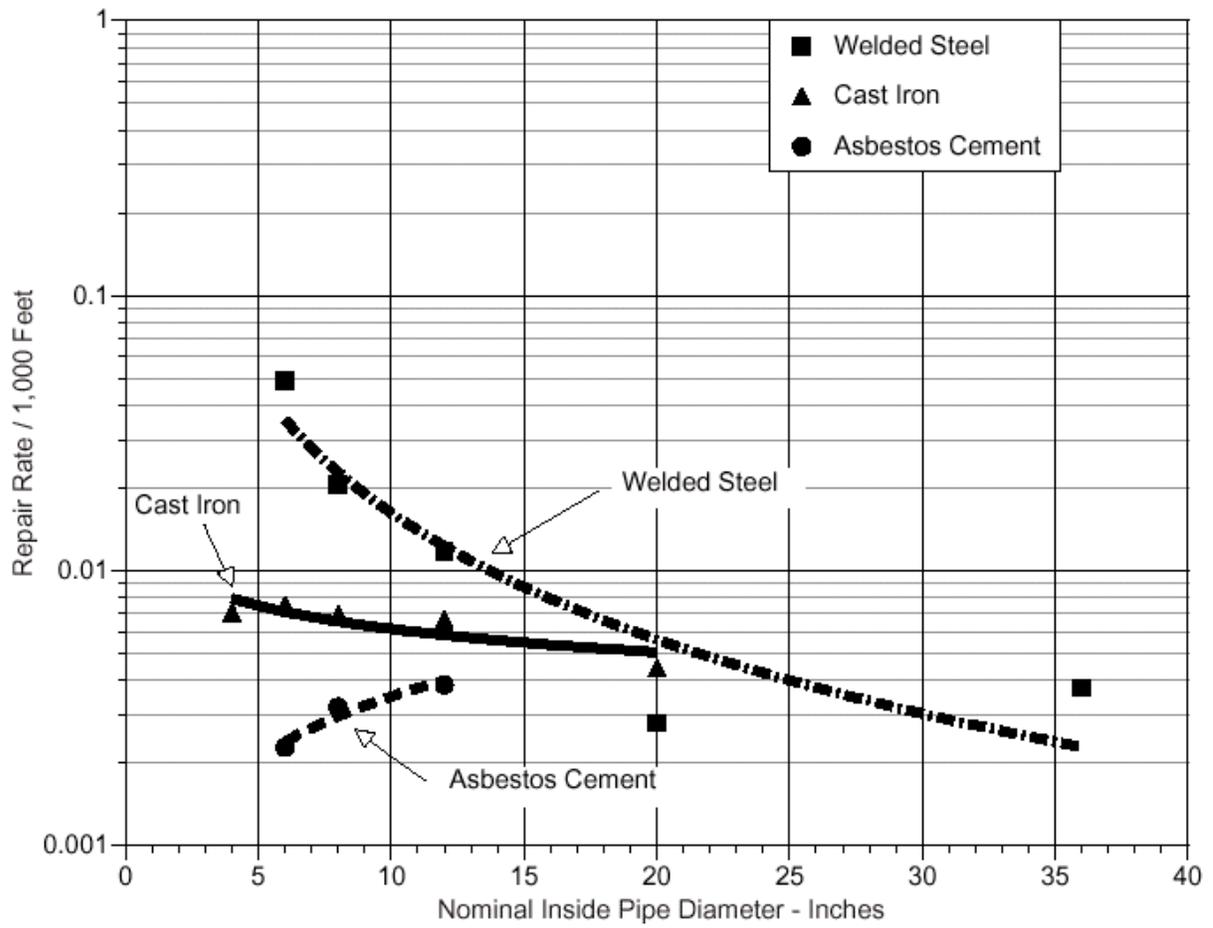
Figure A-11. Repair Rate, Loma Prieta (EBMUD), Ground Shaking, By Material and Diameter

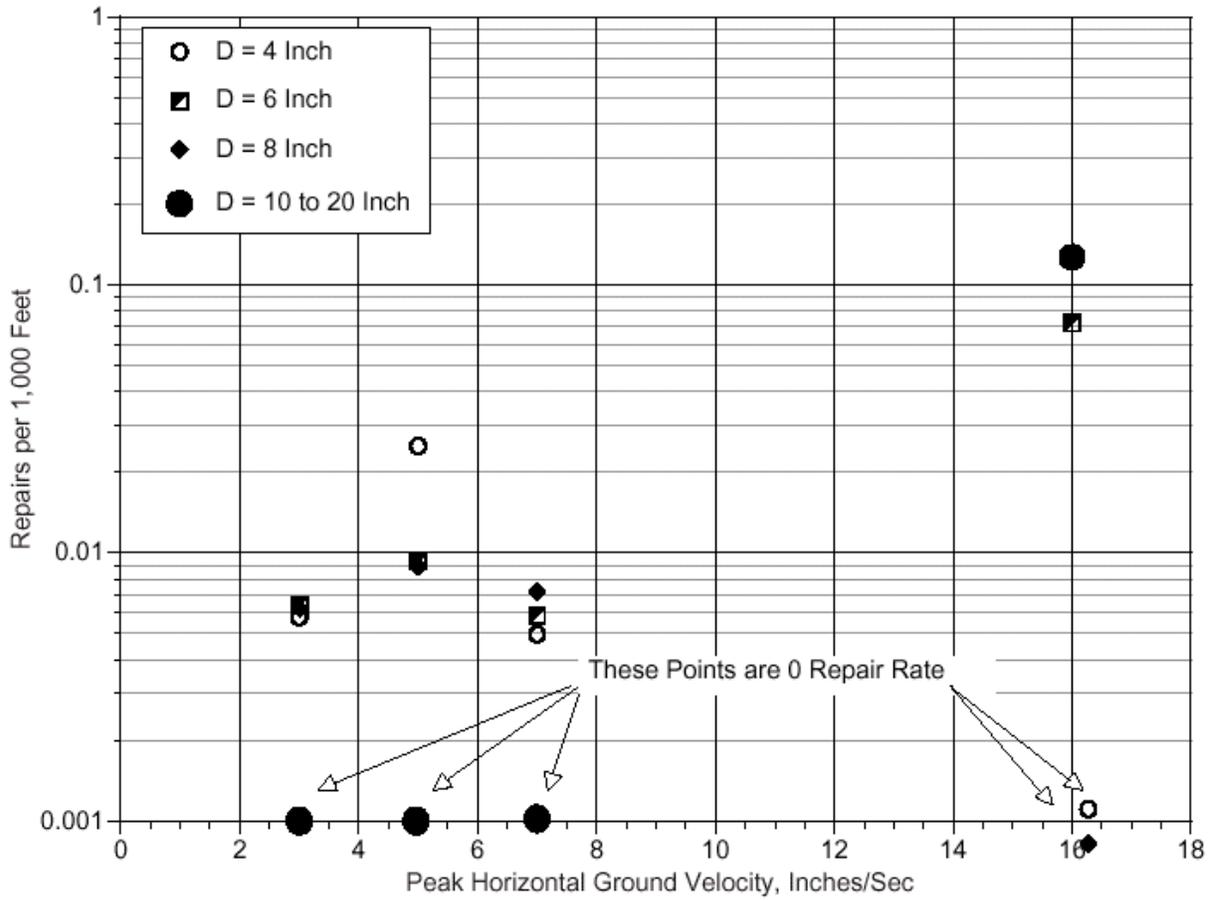
Figure A-12. Repair Rate, Wave Propagation, Cast Iron, Loma Prieta, By Diameter

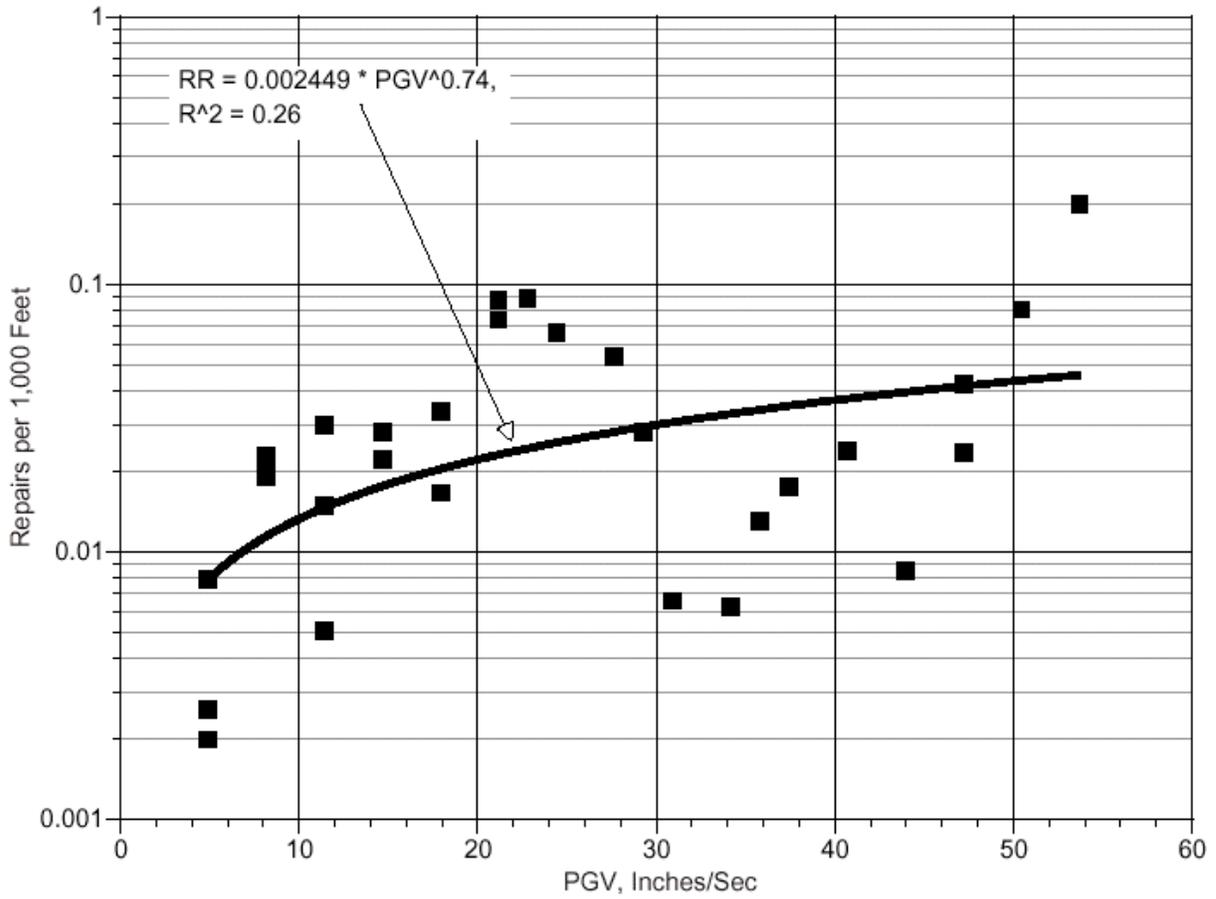
Figure A-13. Repair Rate, Northridge (LADWP), All Materials, Ground Shaking

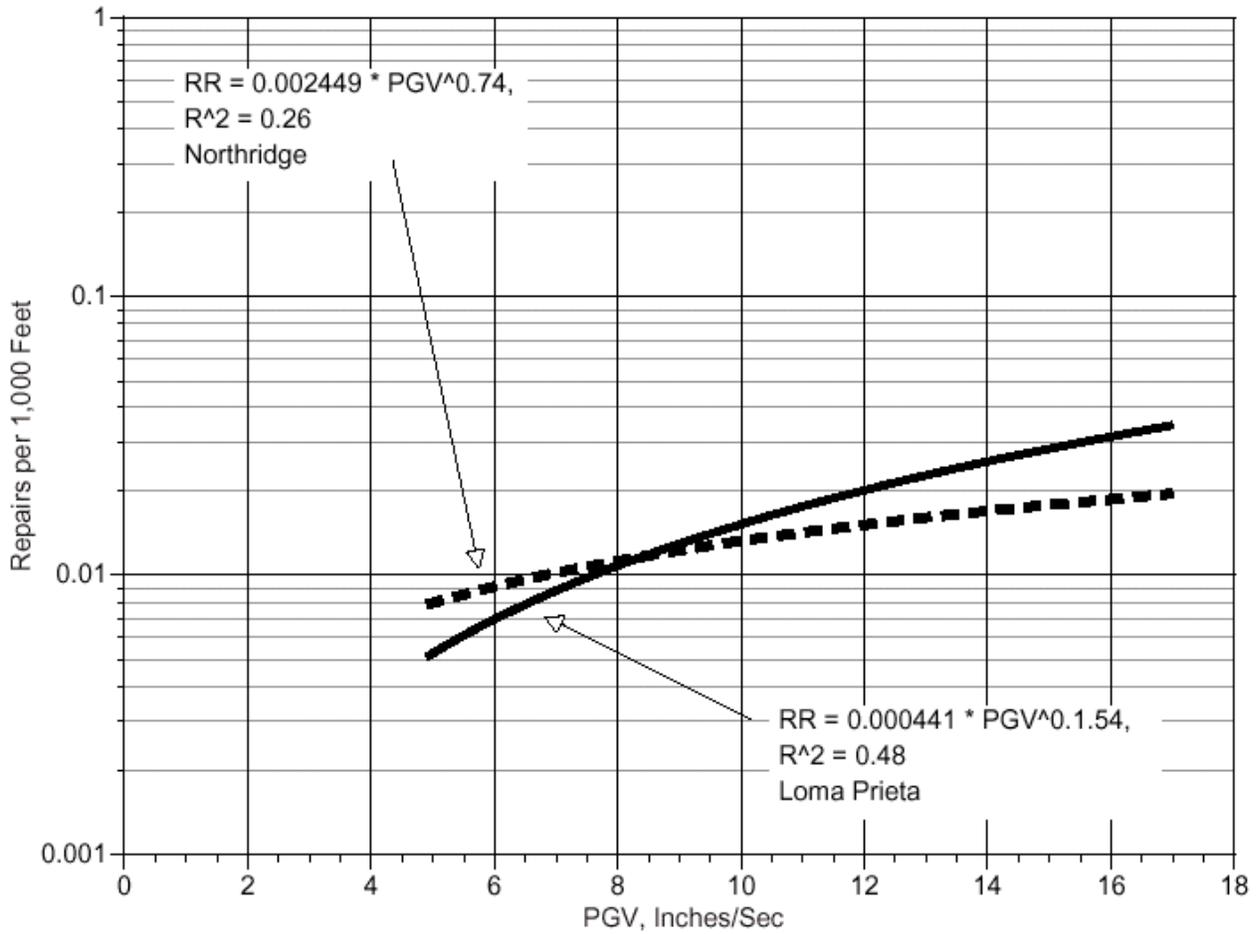
Figure A-14. Repair Rate, Northridge (LADWP) vs. Loma Prieta (EBMUD), All Data

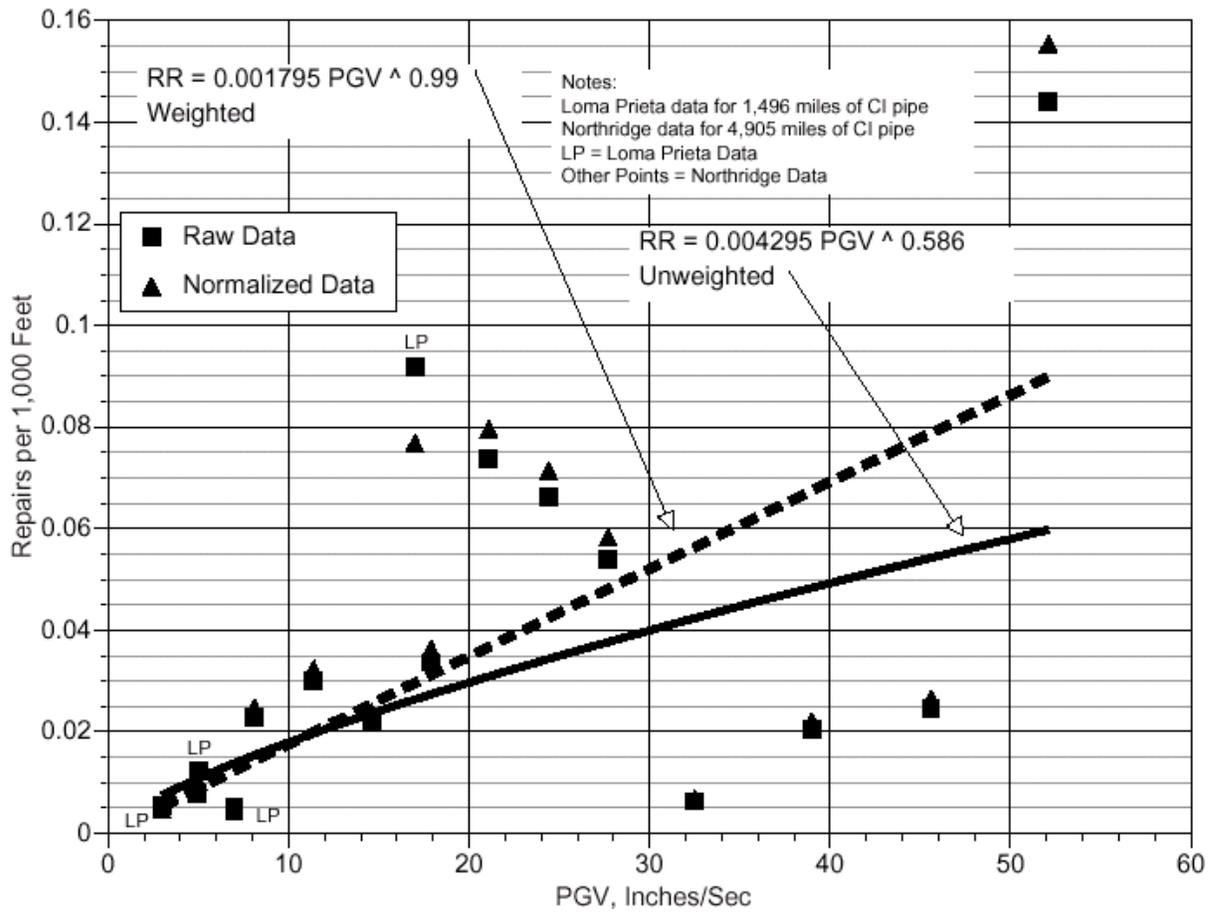
Figure A-15. Repair Rate, Northridge (LADWP) and Loma Prieta (EBMUD), Cast Iron Pipe Only

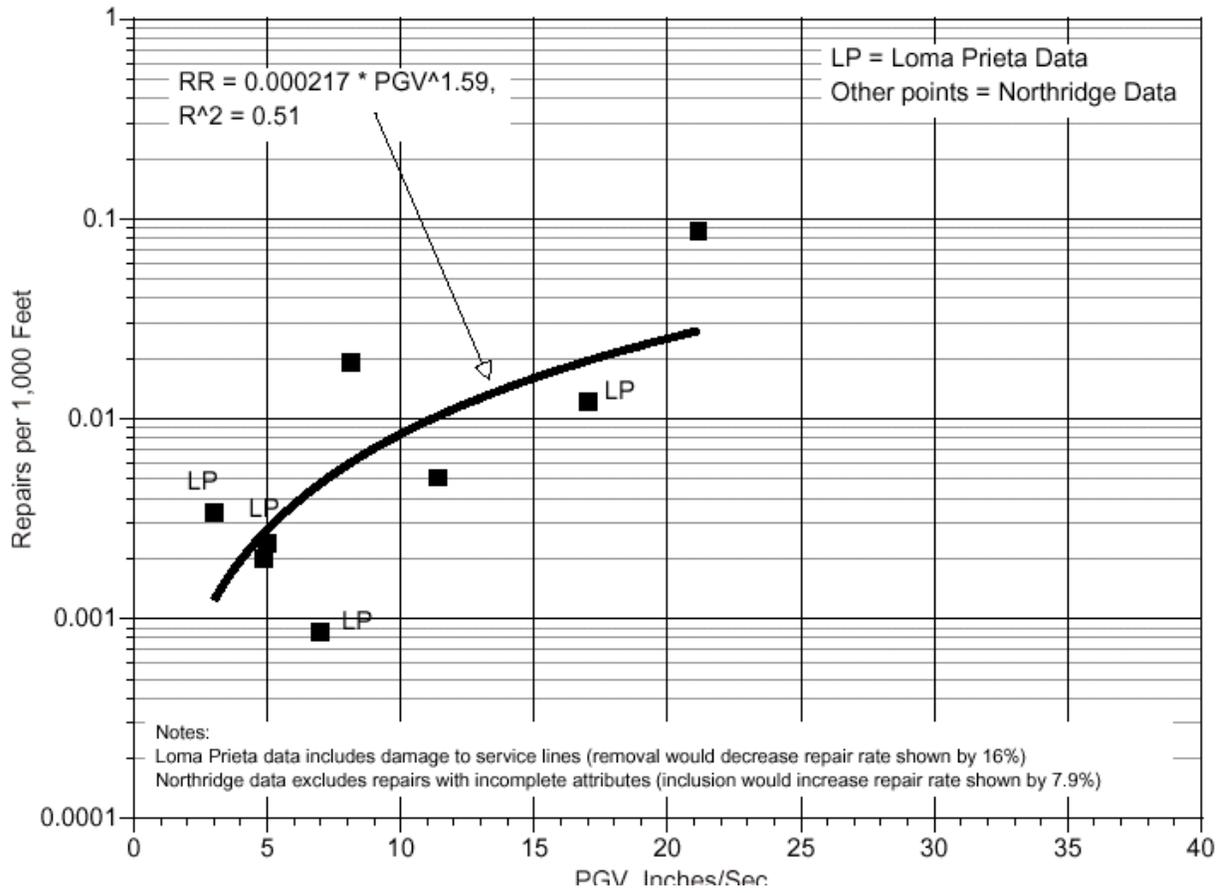
Figure A-16. Repair Rate, Northridge (LADWP) and Loma Prieta (EBMUD), AC Pipe Only

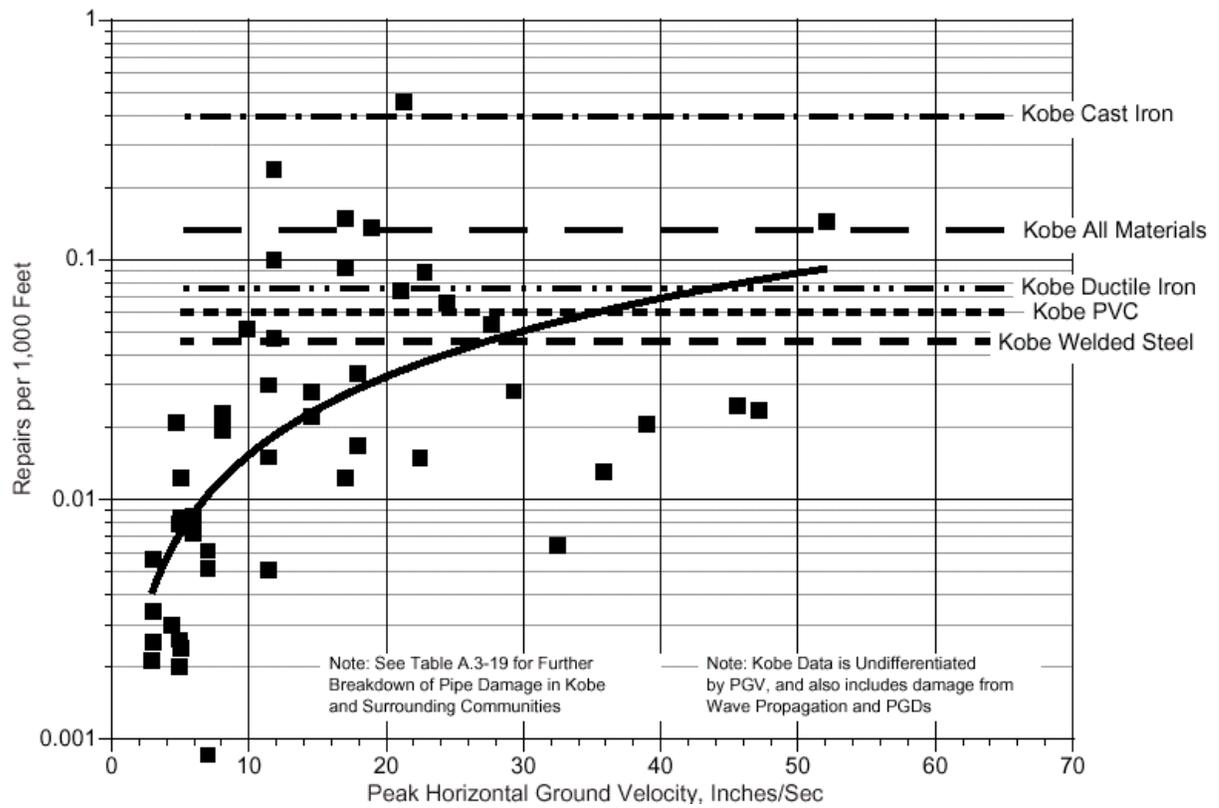
Figure A-17. Pipe Damage – Ground Shaking Data in Tables A.3-4, A.3-14, A.3-15, A.3-16, Figures A-1 and A-2, plus All Data (PGV and PGD) from Kobe, 1995

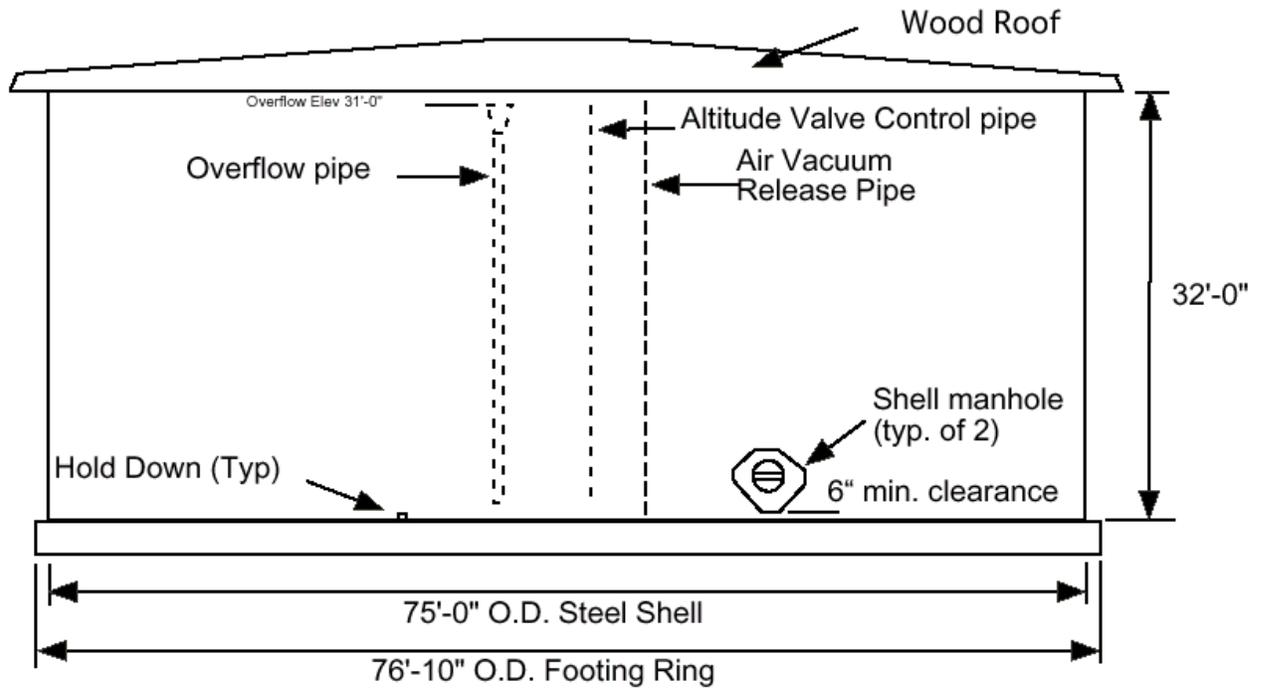
Figure B-1. Elevation of Example Tank

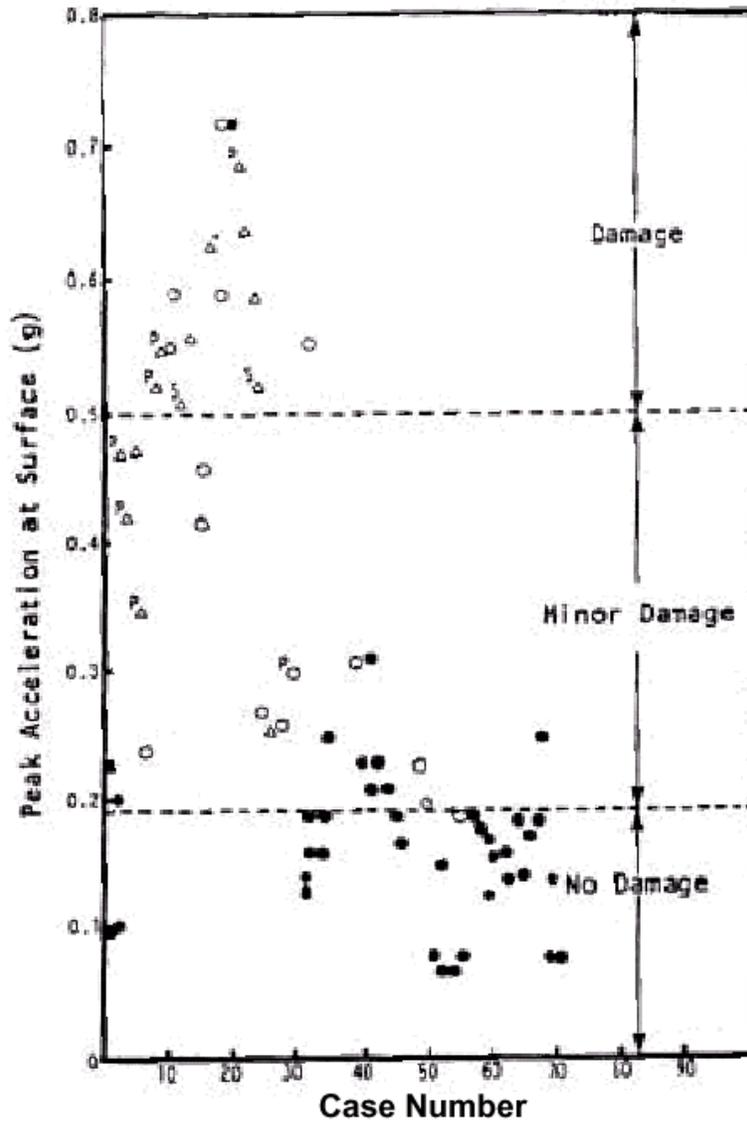
Figure C-1. Peak Surface Acceleration and Associated Damage Observations for Earthquakes [after Dowding and Rozen, 1978]

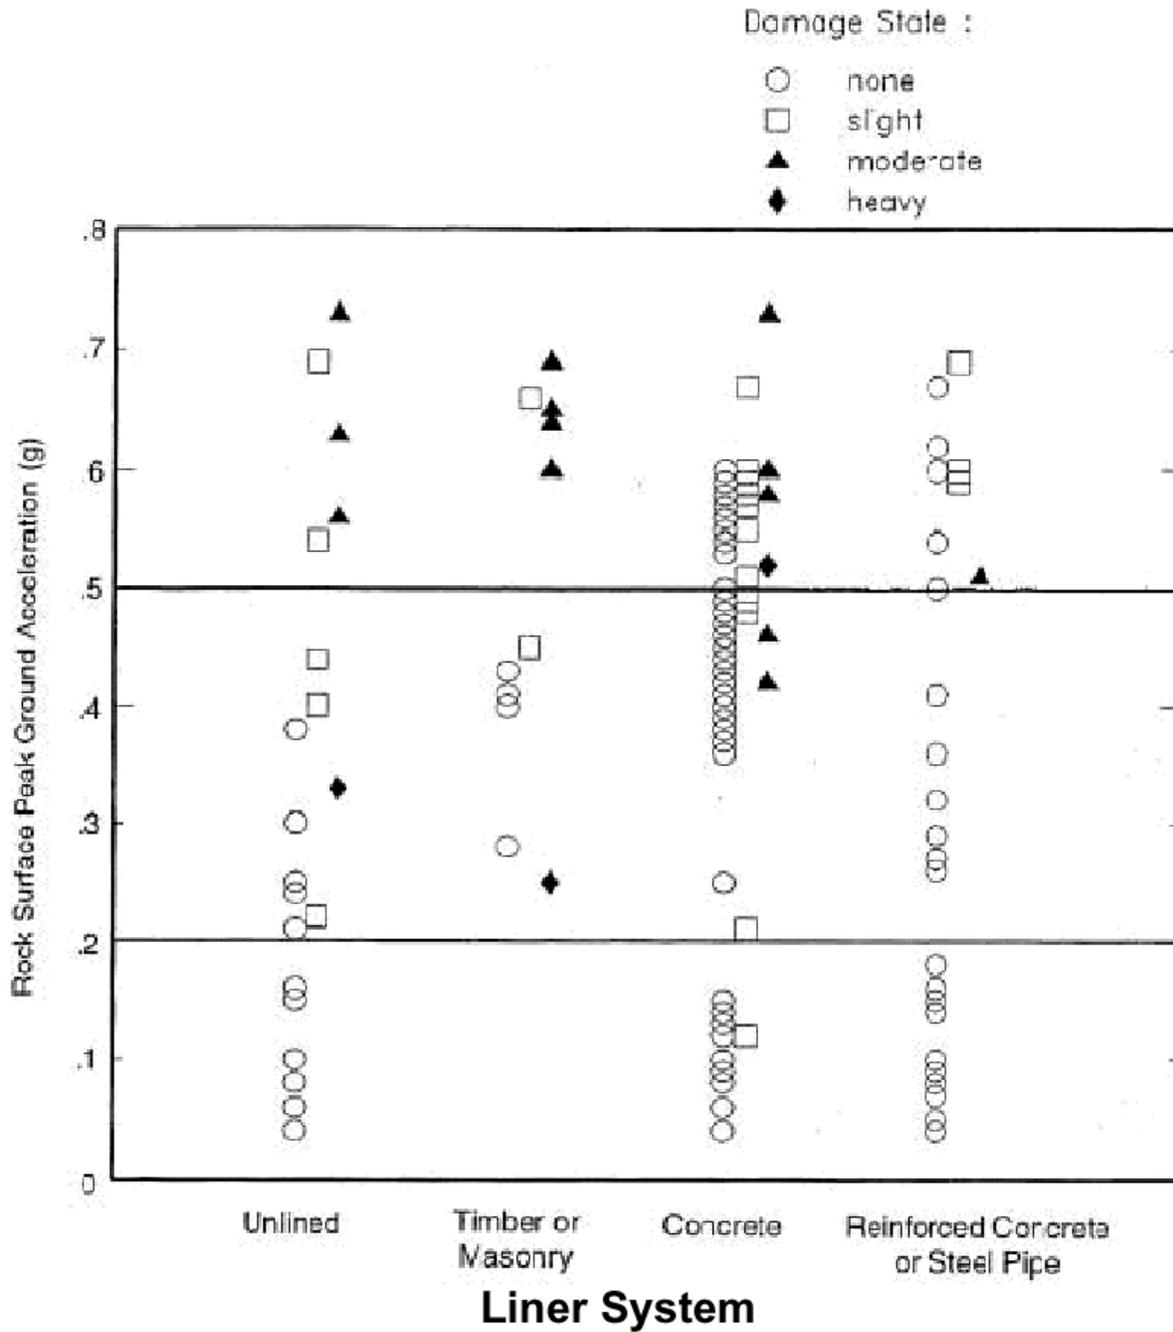
Figure C-2. Summary of Empirical Observations of Seismic Ground Shaking-induced Damage for 204 Bored Tunnels [after Power et al, 1998]

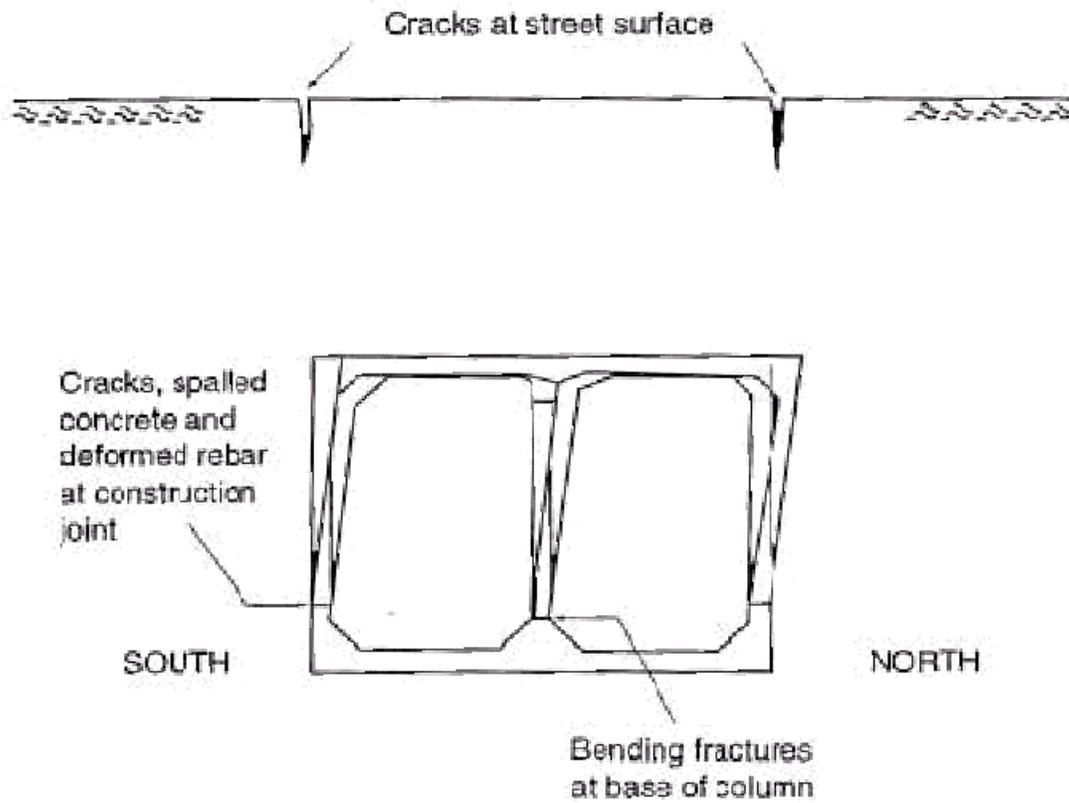
Figure C-4. Deformations of Cut-and-cover Tunnel for Kobe Rapid Transit Railway [after O'Rourke and Shiba, 1997]
