AmericanLifelinesAlliance

Seismic Fragility Formulations For Water Systems

Part 2 – Appendices

April 2001

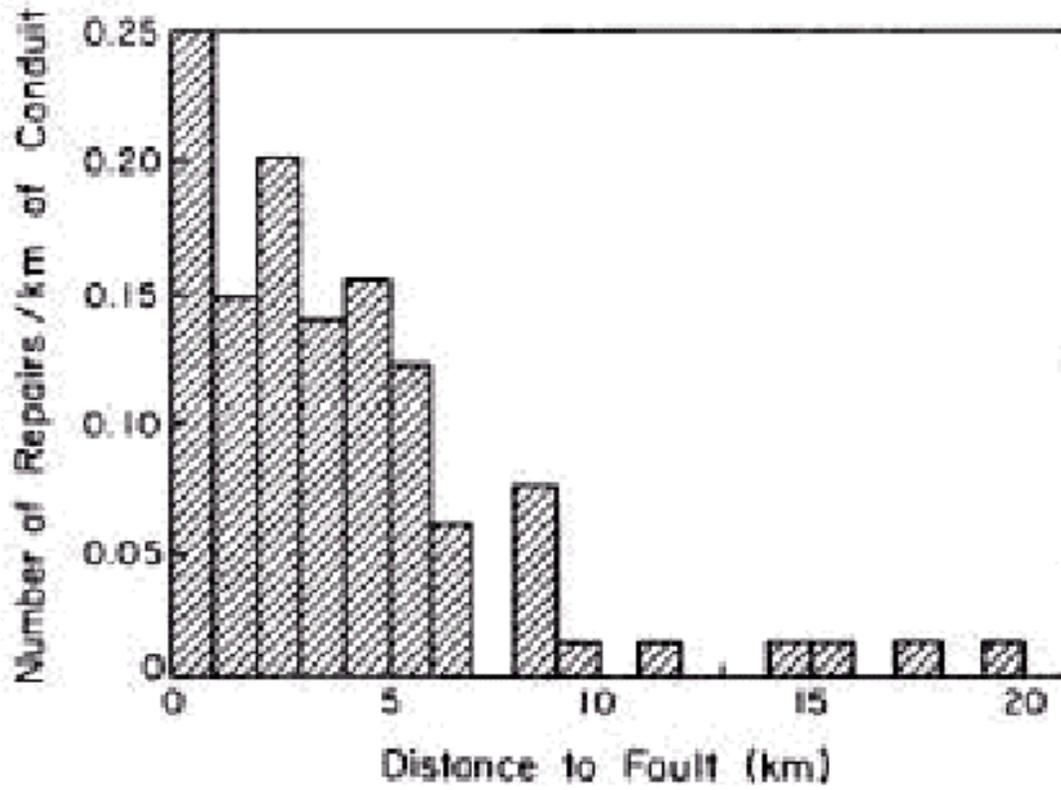
D-1a. Repair Rate versus Distance to Nearest Fault

Figure D-1. Canal and Ditch Repair Rates, 1979 Imperial Valley Earthquake [after Dobry et al]

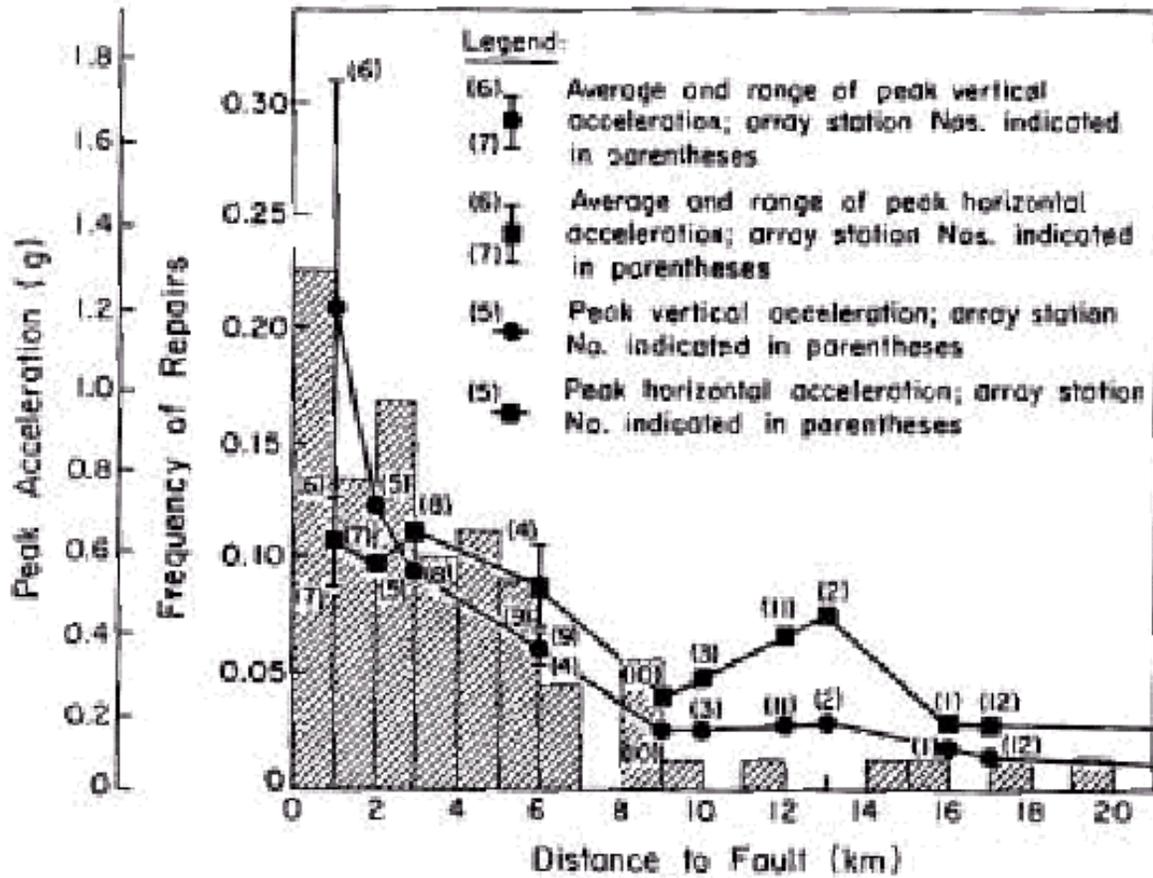
D-1b. Repair Rate versus PGAs Recorded at Similar Distances to the Nearest Fault

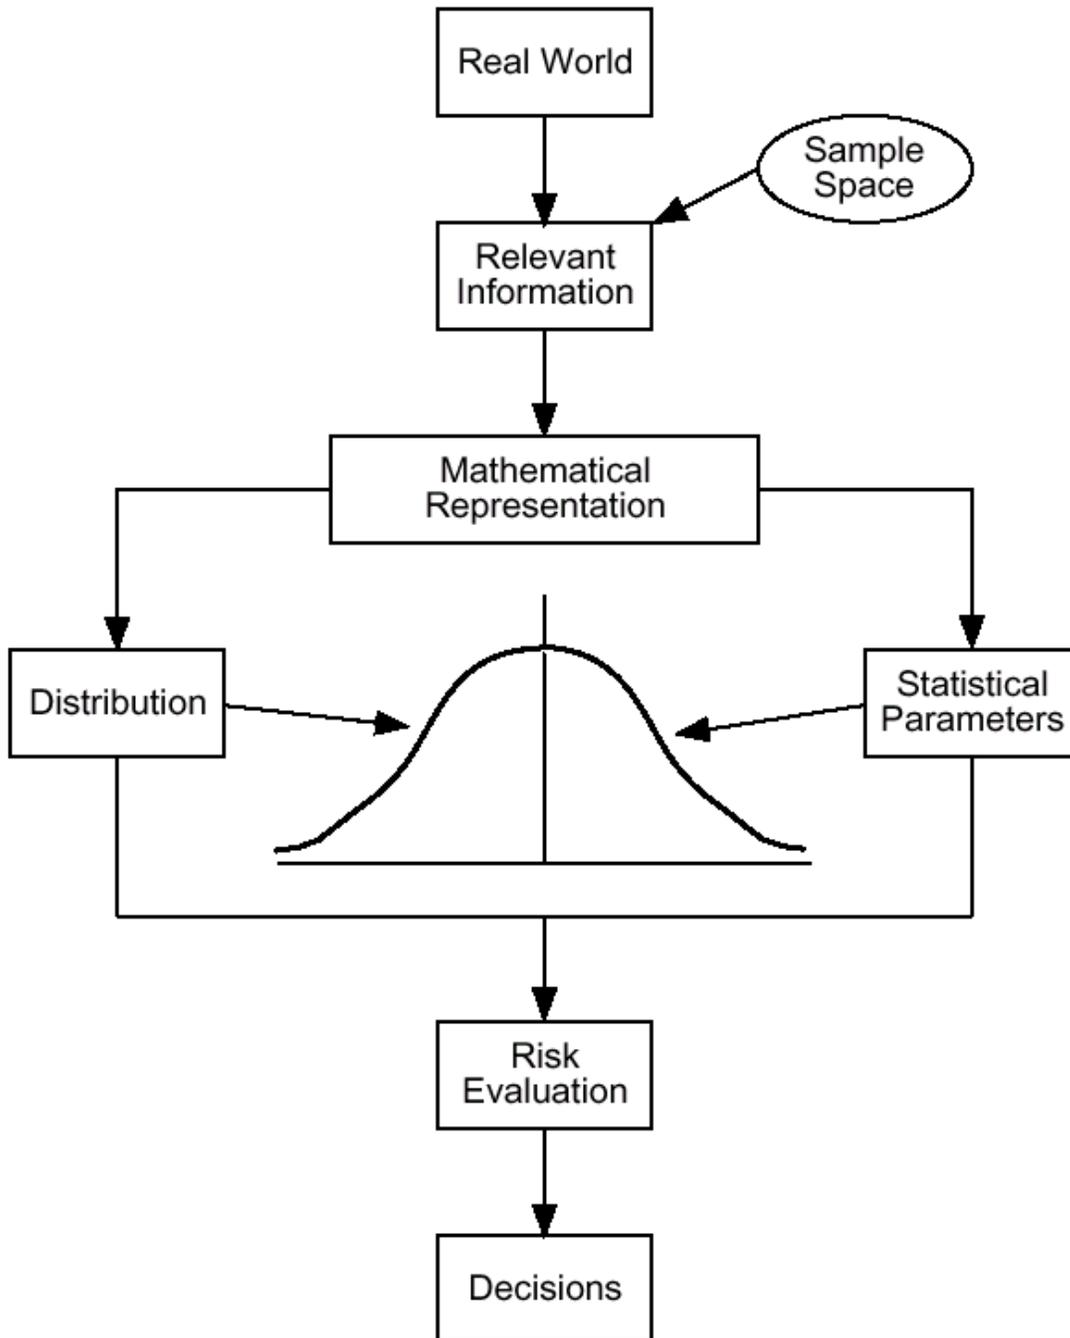
Figure E-1. Steps in a Probabilistic Study

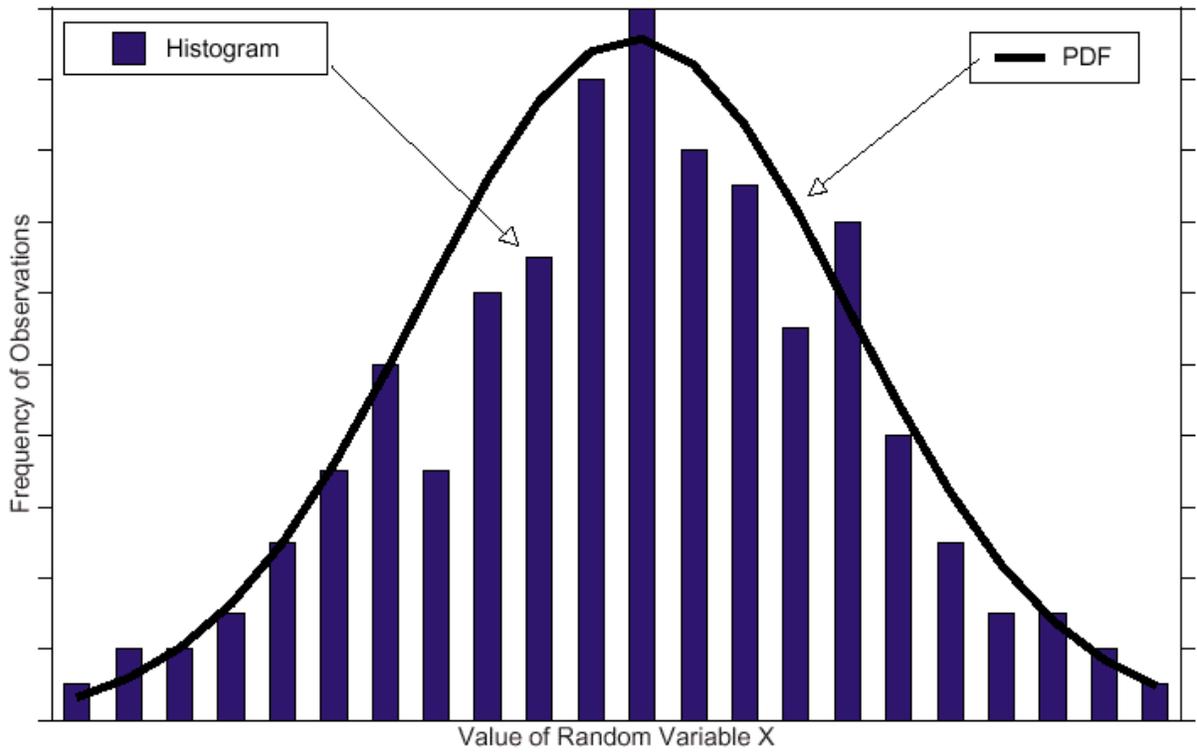
Figure E-2. Typical Histogram or Frequency Diagram

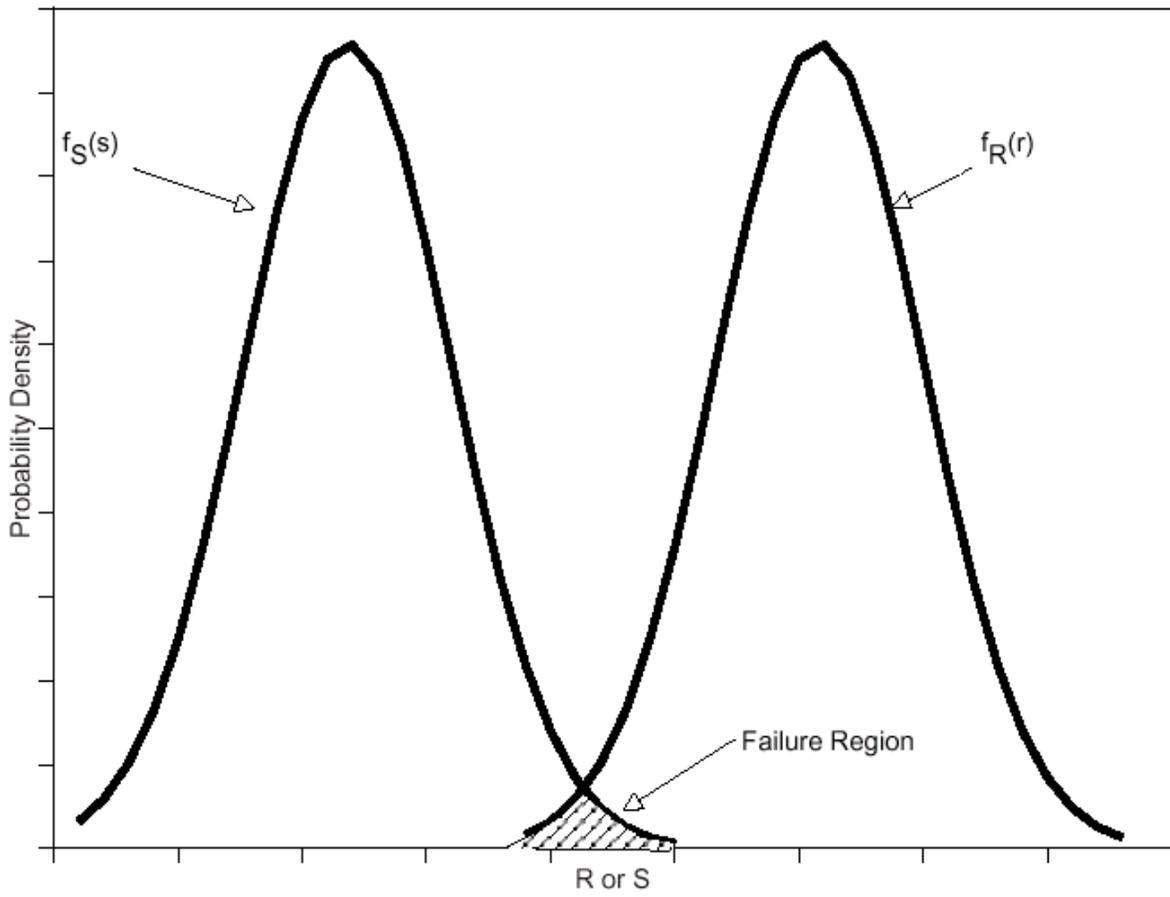
Figure E-3. Risk Evaluation

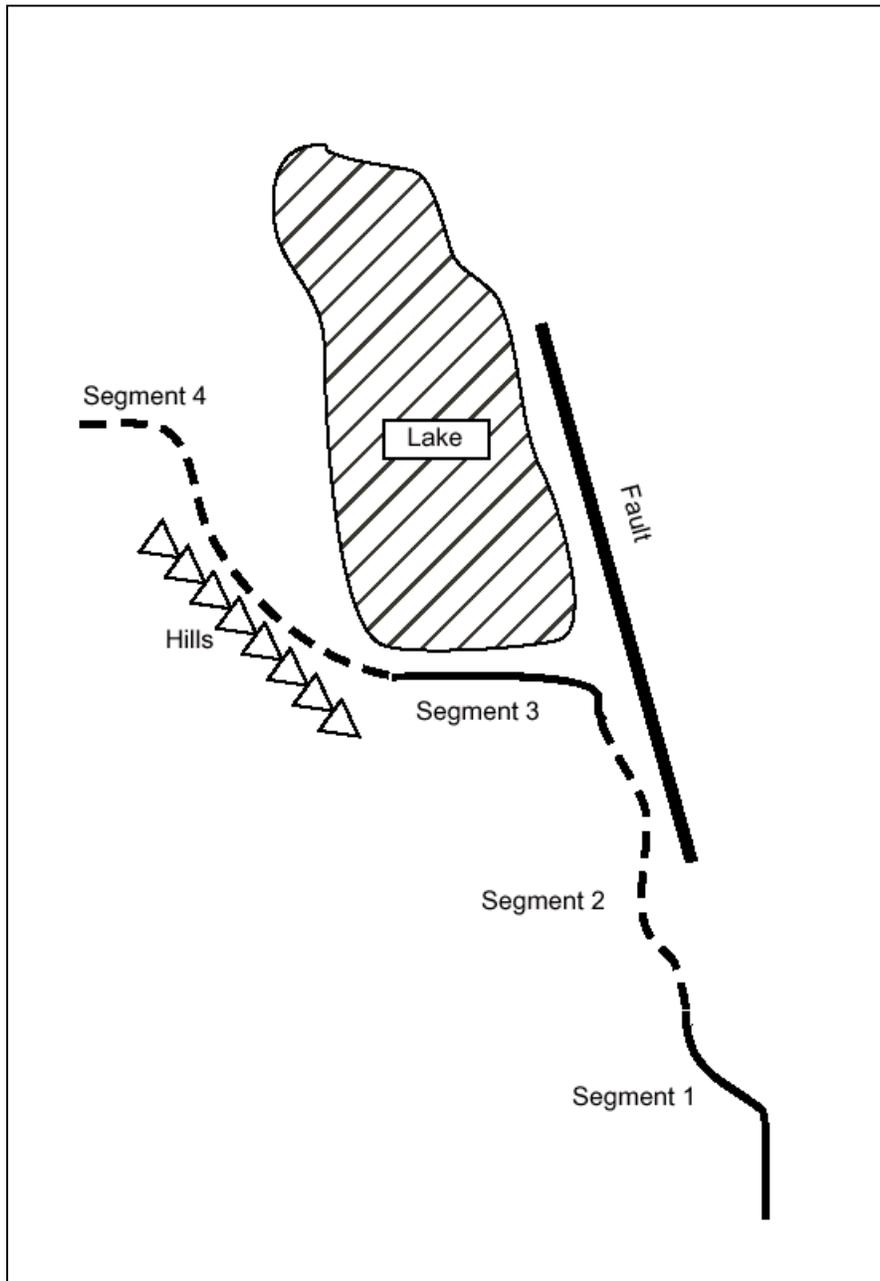
Figure F-1. Example Water Transmission System

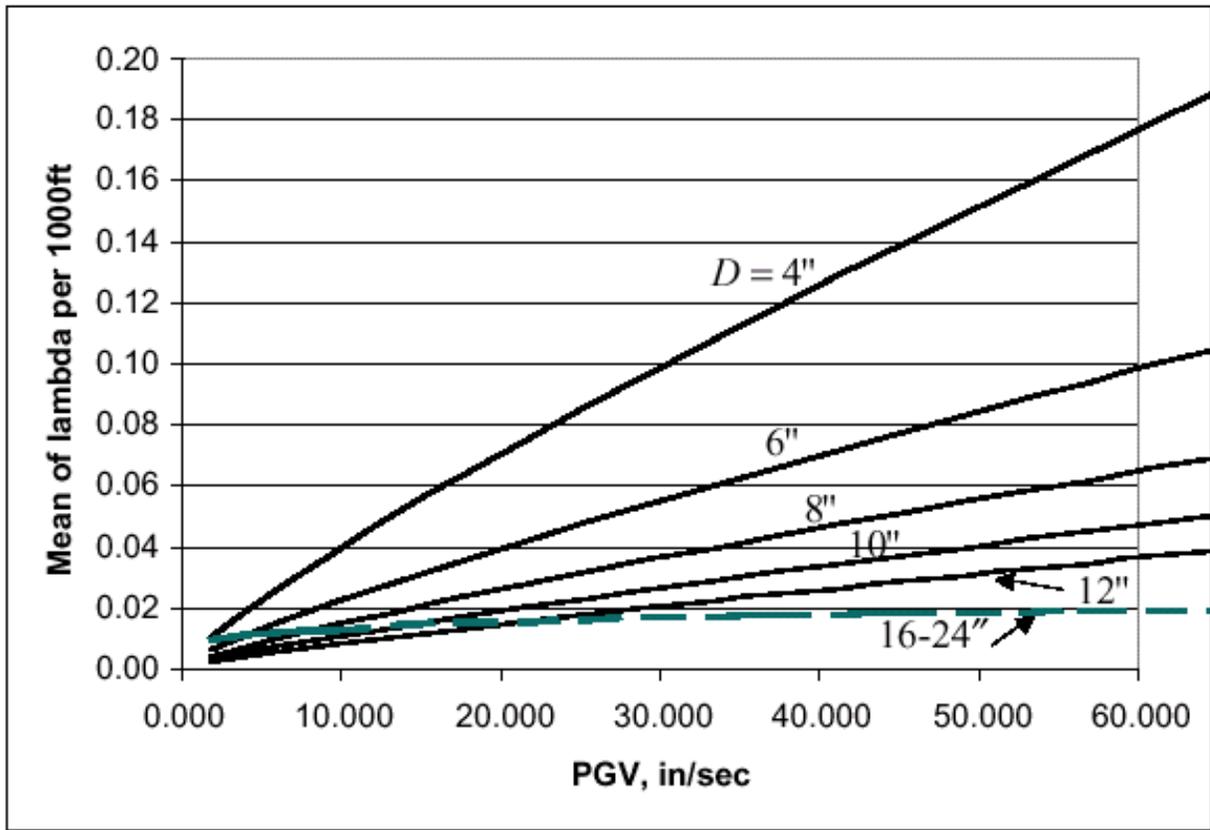
Figure G-1. Mean of λ for CI Pipes

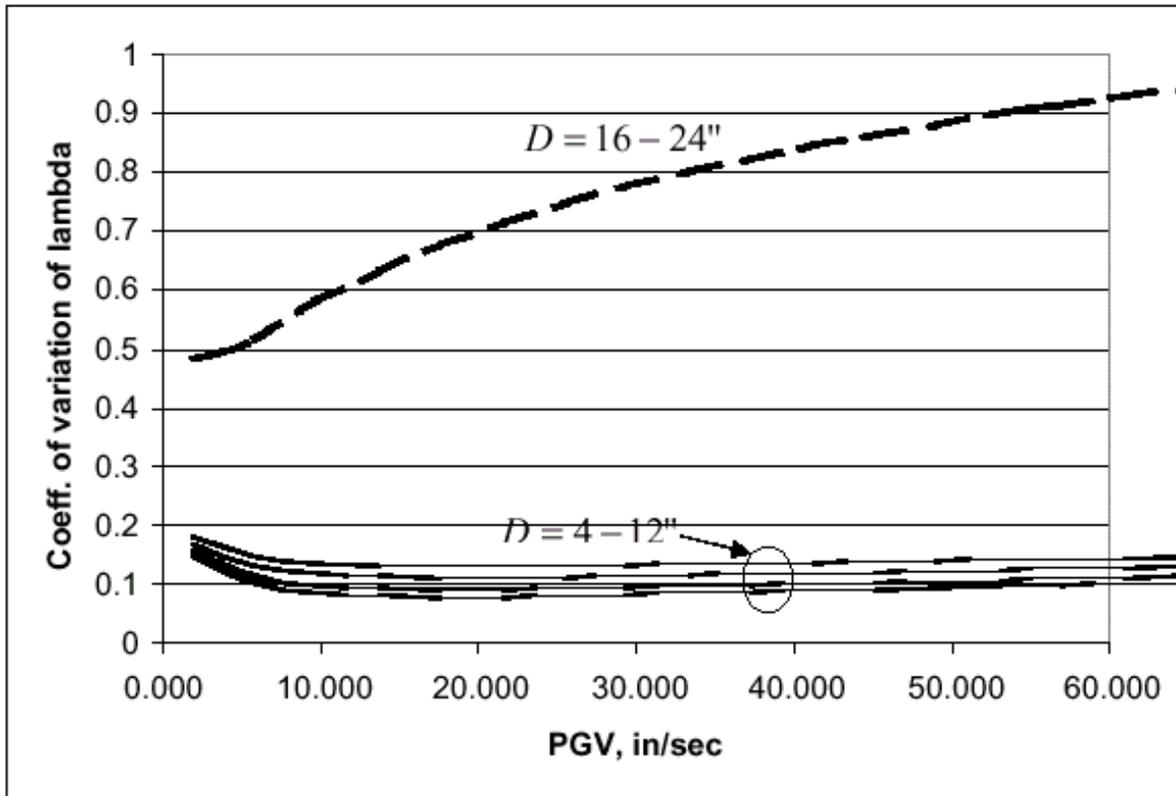
Figure G-2. Coefficient of Variation of λ for CI Pipes

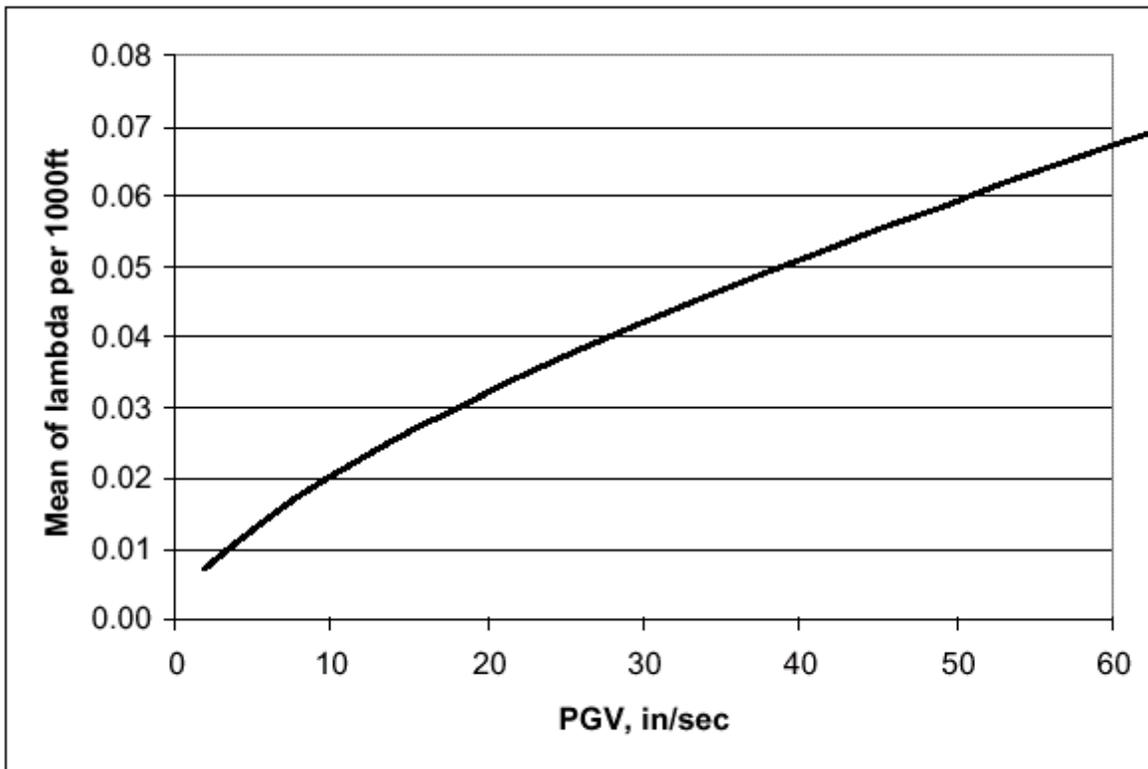
Figure G-3. Mean of λ for DI Pipes

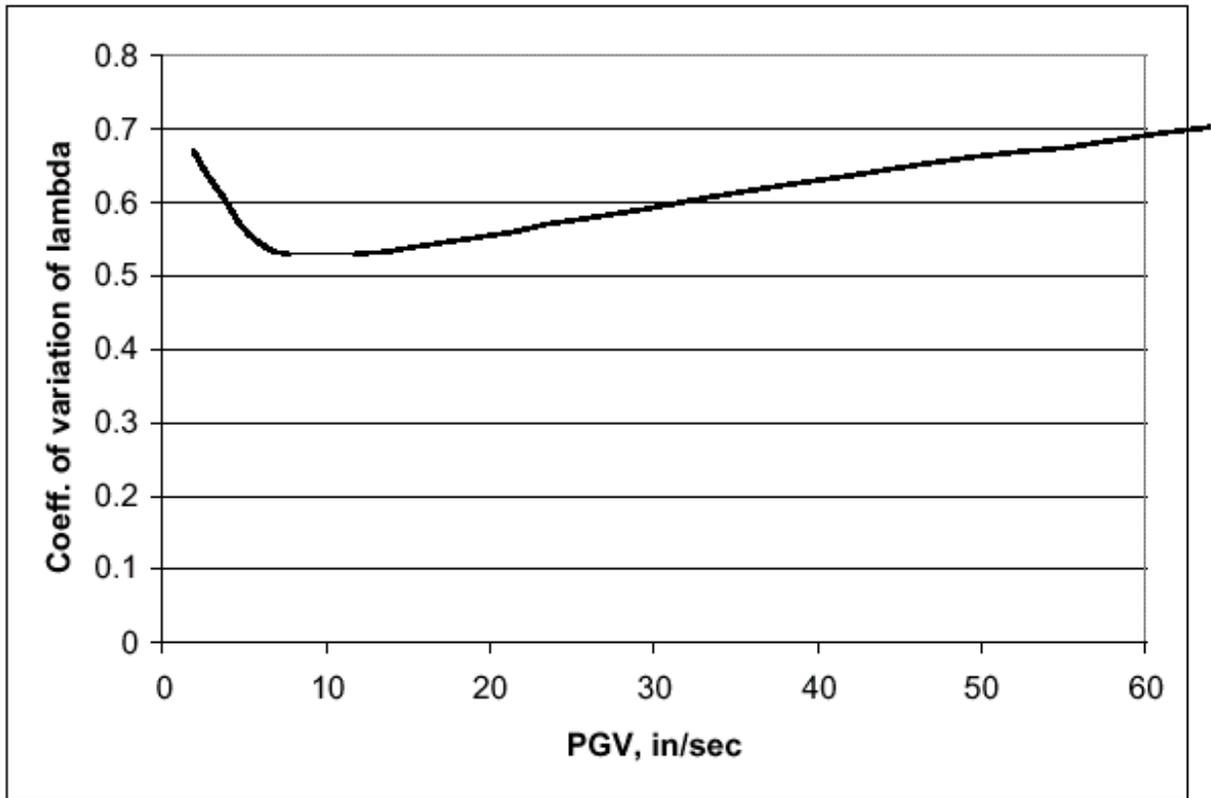
Figure G-4. Coefficient of Variation of λ for DI Pipes

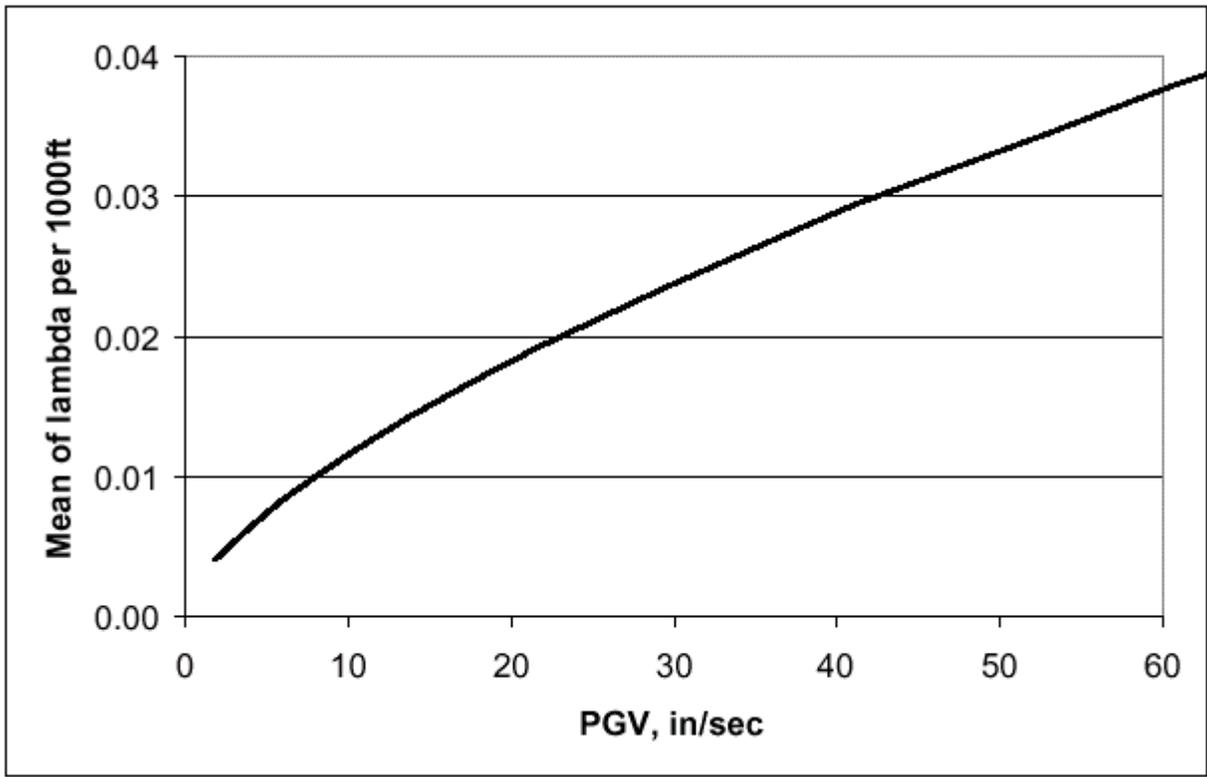
Figure G-5. Mean of λ for AC Pipes

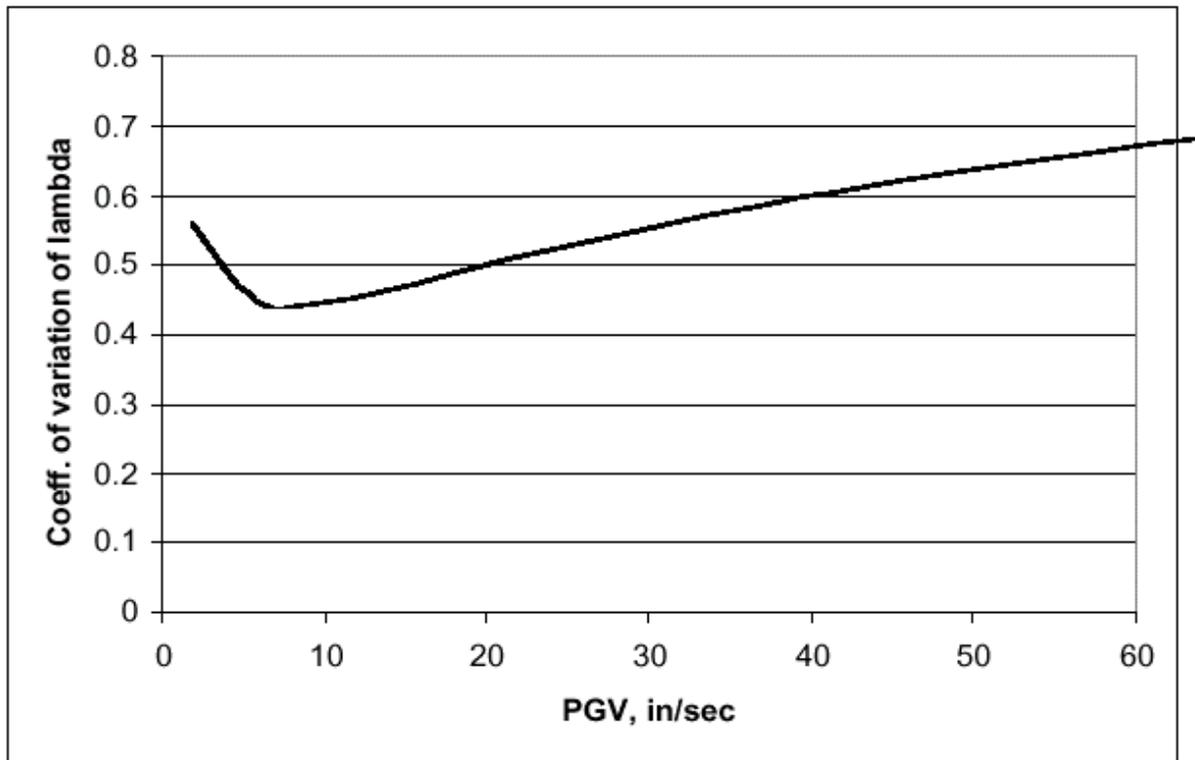
Figure G-6. Coefficient of Variation of λ for AC Pipes

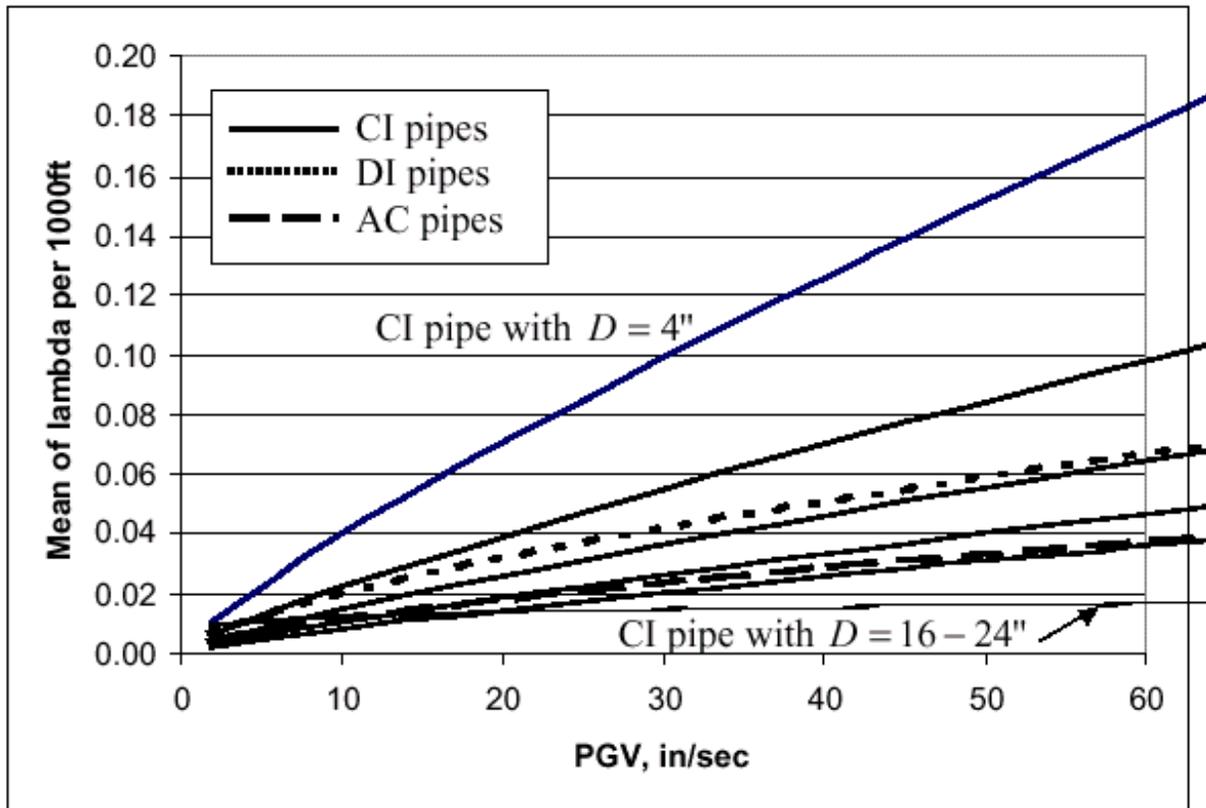
Figure G-7. Comparison of Mean of λ for Pipes of Different Materials and Diameter

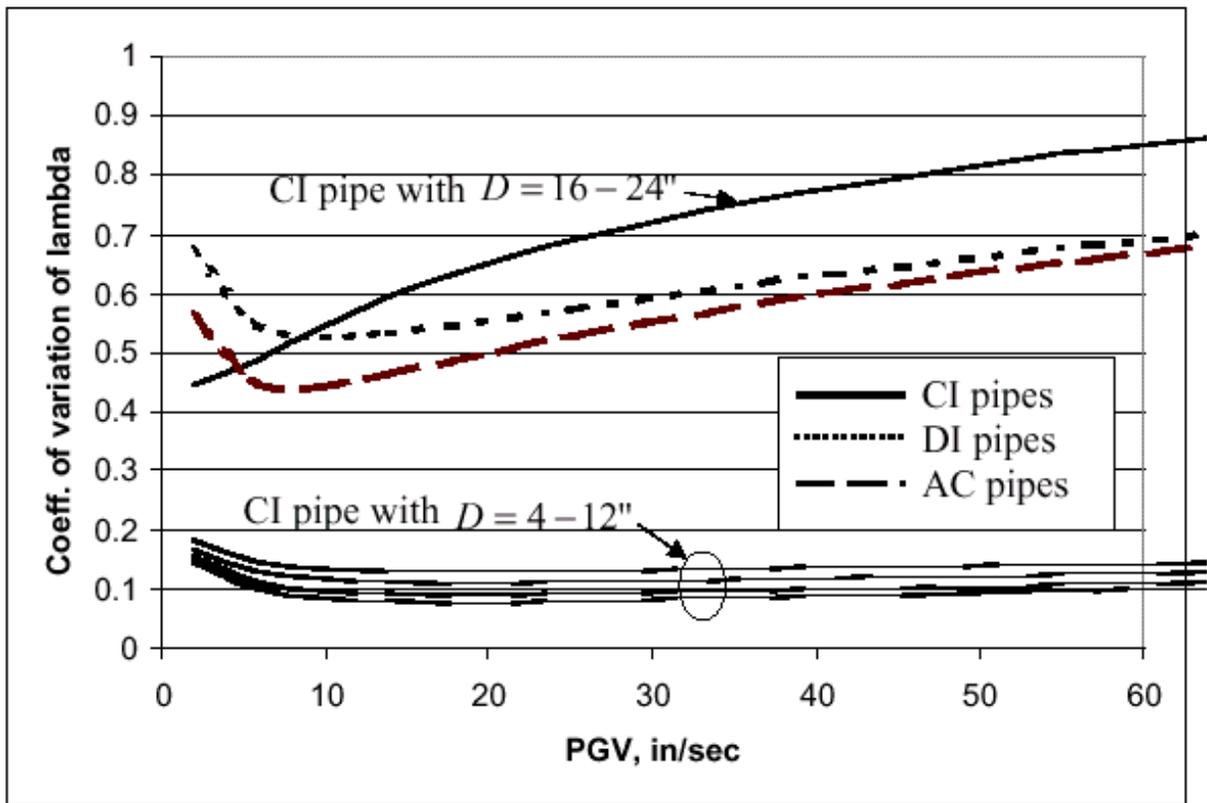
Figure G-8. Comparison of C.O.V. of λ for Pipes of Different Materials and Diameter
